# Rockfall Hazard Assessment Around Ankara Citadel (Turkey) Using Rockfall Analyses and Hazard Rating System

Nyein Ei San · Tamer Topal · Muge K. Akin

**Abstract** Ankara Citadel which is one of the important cultural heritages in Turkey settles in the oldest part of Ankara. Rockfall event has occurred around the Citadel located on a steep hill where andesite is exposed. The rockfall problem causes a great risk to the surrounding area where road, school, floral shops, car parking. Therefore, the major aim of this research is to reveal the rockfall risk around the castle. The rockfall problems around the Ankara Citadel may be linked with weathering, freezing–thawing, earthquake, and cooling joints, and effects or combination of these in the rock units. The rockfall-related hazard at the Citadel is assessed by 2-D rockfall analyses along several profiles in this investigation. Field observations and stability analyses (kinematic and limit equilibrium) of the slopes reveal that there exist many blocks ready to fall down. Four different andesite block sizes measured in the field are separately analyzed on the basis of bounce height, fall-

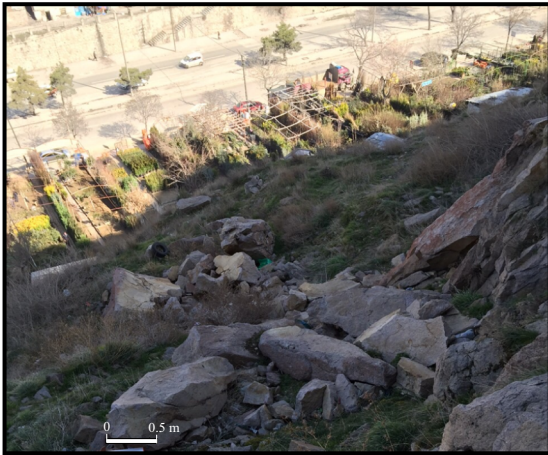
**Fig. 3** Fallen blocks seen near the floral shops and the road

The field studies reveal that there exist some blocks already fallen in the past. The data (1941 discontinuity measurements in total) of the scanline survey at each stop and altogether around the castle were contoured (Fig. 5) using Dips 6.0 software (Rocscience 2015a). There are flow layers of the andesite with nearly low dip amount in the area. They can be traced easily and mainly scattered around the center of the contour diagram as can be seen in Fig. 5. Several steeply dipping cooling joints developed in different directions almost perpendicular to the flow layers also exist in the area. This indicates that the andesite is highly-jointed (Fig. 6). The joints have persistence dominantly  $< 5$  m. However, it may locally reach around 15 m. The spacing of the discontinuities ranges between 2 and 200 cm (moderately narrow to very wide) with a concentration mostly around 20–60 cm (wide). The apertures are generally tight with clay filling (maximum 2 cm) near the surface. Nevertheless, no infill material exist along the flow layers due to their low dip angles. The other properties of the flow layers are observed to be similar to the cooling joints. The Schmidt hardness rebound values range between 25 and 41. The mass weathering of the andesite is in

biggest fallen block has a dimension of  $160 \times 80 \times 60$  cm corresponding to a weight of nearly 1800 kg. Although there is a possibility that some larger blocks felt but fractured during bouncing, the authors have rarely observed clear evidences of such conditions during the field studies. Additionally, the biggest fallen block size is in well agreement with the measured spacing ranges of the discontinuities. Therefore, the biggest fallen block weight was considered as the worst case in the rockfall analyses. Several blocks were also obtained from the field taken to determine identify the engineering properties of the rock. Oriented NX-size cylindrical samples with length to diameter ratio of 2.5 were prepared from the blocks for the uniaxial compressive strength test. However, cubic specimens with  $7 \times 7 \times 7$  cm dimensions were used for the determination of unit weight, effective porosity, water absorption, and sonic velocity. Additionally, direct shear test was carried out along saw-cut surfaces of the rock.

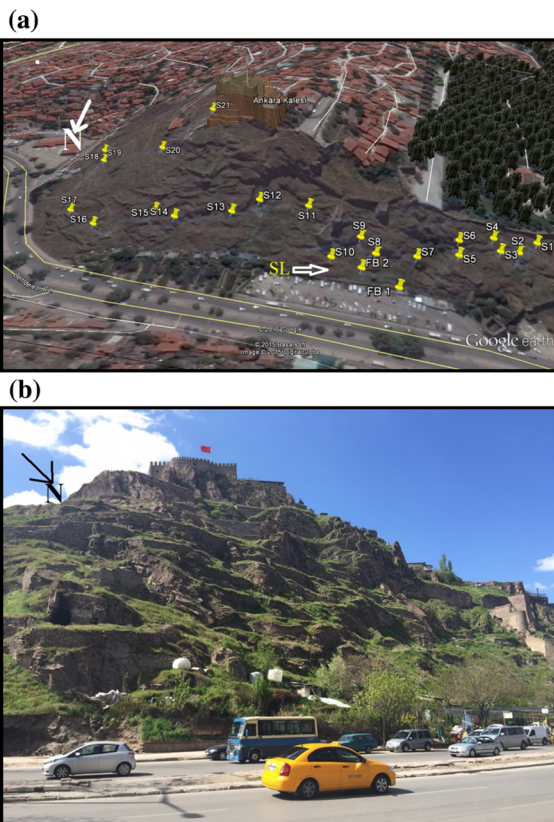
**Fig. 4** **a** Scanline survey (S) and fallen block (FB) locations, **b** Photograph of the northern part of the Ankara Citadel where measurements were done

Upper Miocene Mamak formation is the main lithological unit observed in the study area (Akyürek et al. 1997) (Fig. 4). Although it contains agglomerate, tuff, andesite and basalt, andesite having steeply joints is the dominant rock type exposed in the study area. The andesite is formed during Miocene (Erol 1961; Erentöz 1975). The rock is mostly pinkish grey and slightly to moderately weathered. The highly fractured andesite has cooling joints and flow layers forming the steep topographic features at different elevations around the Ankara Citadel (San 2017). The petrographic analysis of the andesite mainly points out the presence of plagioclase, hornblende and biotite. According to Tokmak (2005), some volcanogenic fragments, opaque amorphous formations and clay minerals can be seen as secondary minerals in the andesite.

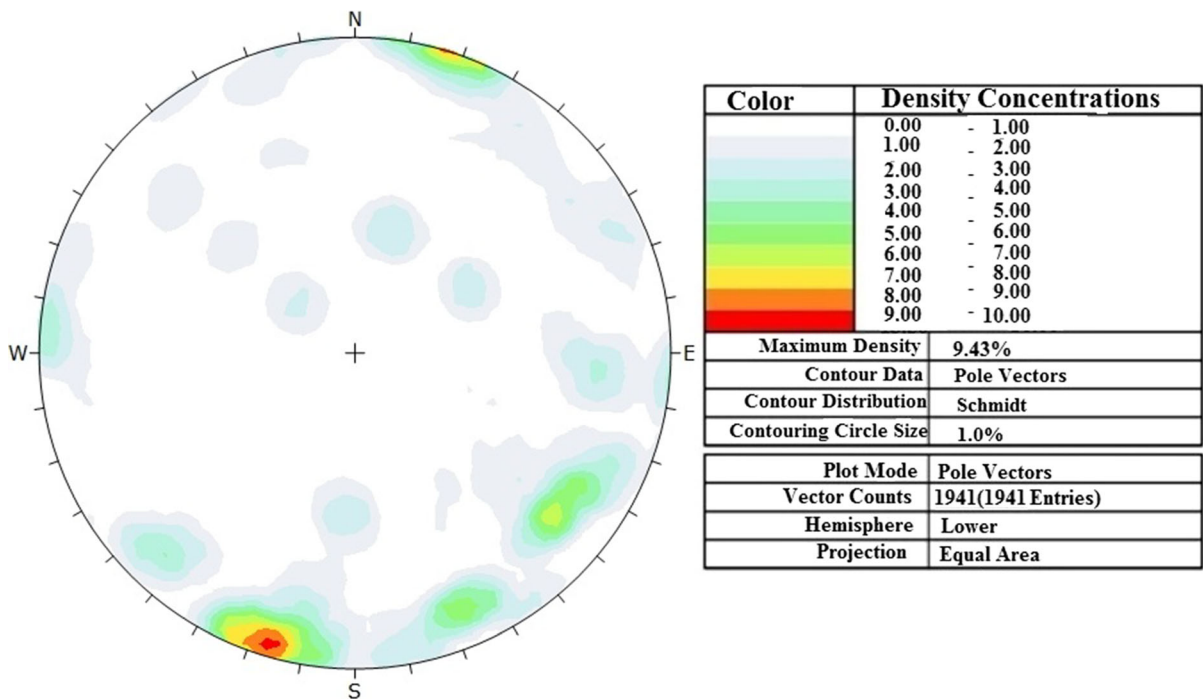
**Fig. 5** Contour diagram of the discontinuities measured during the scanline survey

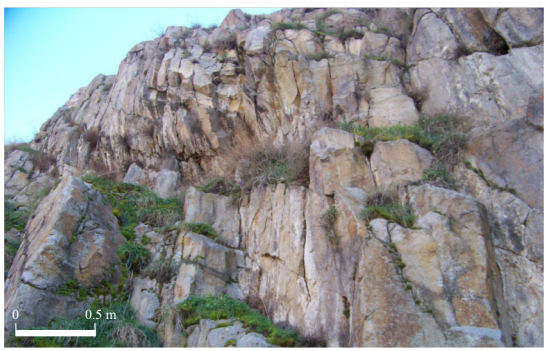
**Fig. 6** Highly-jointed andesite at 4th (S4) location
