THE RESTITUTION PROCESS IN CONSERVATION: DISCOVERING THE HISTORY OF ŞEHİT ALİ PAŞA LIBRARY (1)

THE CASE STUDY: ŞEHİT ALİ PAŞA LIBRARY

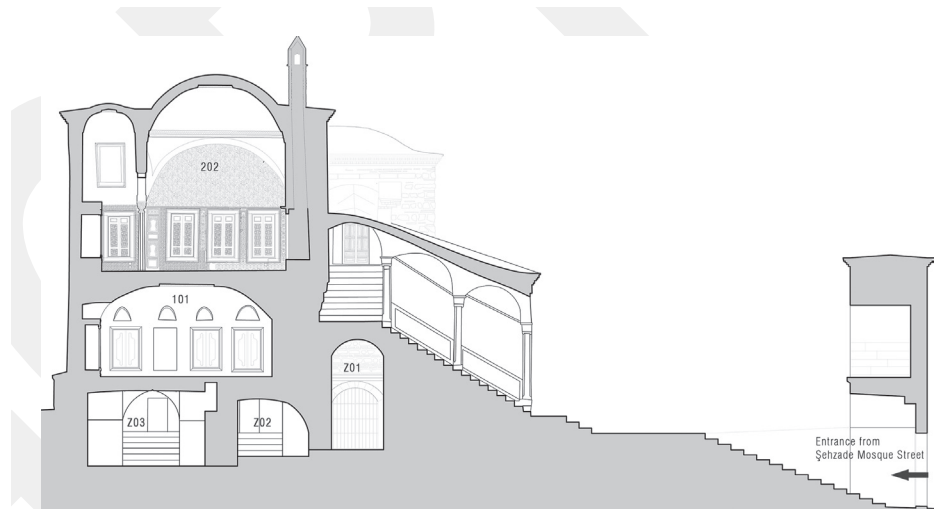
Figure 7. Şehit Ali Pasa Library Section-1, 2012.

Şehit Ali Paşa Library is currently located in the courtyard of Vefa High School in Istanbul and was used as storage of the school for a while. So, the entrance is under control of the school management and after KADEM Foundation (4) has rent the building, it is also accessible from the gate on the Şehzadebaşı Mosque Street. The entrance is reached by passing through one of the vaults of the Valens Aqueduct. The garden wall is quite gorgeous to be a garden wall; there are two storeys of huge arches, which strengthen the theory that it was a part of the aqueduct (Figure 6a). The marble inscription is above the gate (Figure 6b), and the stairs starting from this door lead to the ground floor of the building. The library consists of two main blocks connecting at the second floor. The library was built as ground floor and two floors; there is a middle landing reaching the first floor, and afterwards, the staircase covered by a vault, is leading up to the second floor (Figure 7).

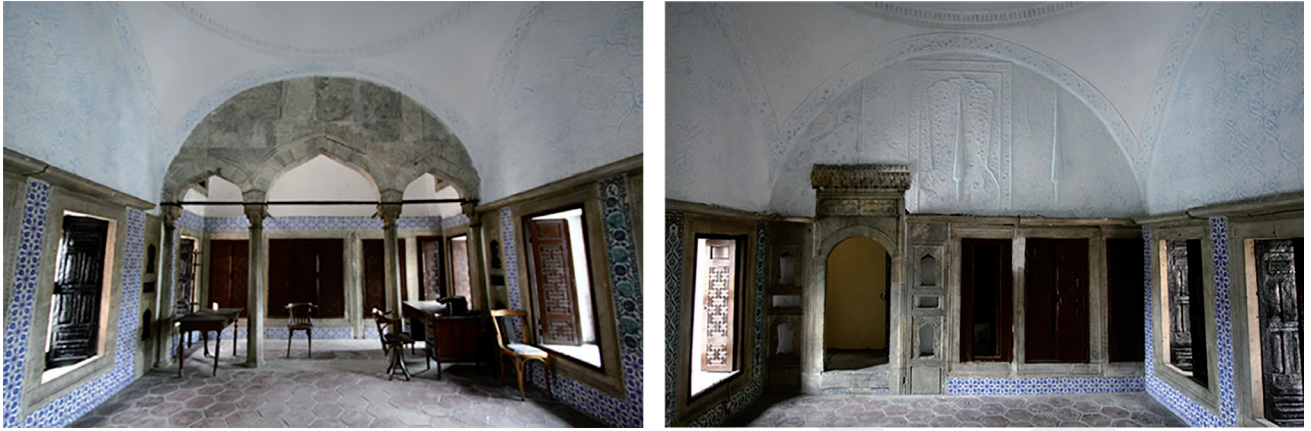
Figure 9. Main Reading Hall, 2012.

The L shaped staircase covered by a vault on the northwest façade leads to the second floor where the main spaces are located. *Küfeki* (7) columns and brick arches are supporting the vault, which stuck to the façade with an iron bar. The staircase leads to the space 201 closed by the original iron cast door. Two columns, which are typically same as the ones at the staircase, are embedded both sides of the door. The main space of the library is reading room where also the books were stored, is named as 202 (Figure 8c), and is connected to the room 201 with a short and narrow corridor enclosed by two original iron cast doors. This space is the most glorious space of the building in terms of spatiality, variety in use of materials, ornamentation and decorative elements (Figure 9). The space was divided into two parts with marble columns with stalactite capitals and three pointed arches between them. The main square hall is covered with dome, and pendants are used as transition elements. Both of pendants and dome are ornamented with plaster as used *malakari* (8) technique. On the other

hand, the rectangular part of the space is covered by cavetto vault with *şemse* and *Türk üçgeni* ornamentation around it. Furthermore, there are two upper windows at the rectangular shaped secondary part of the space, only can be seen from the interior. On the southeast and northwest walls of the space, six wide niches with *kündekari* (9) wooden shutters are embedded, which are considered as book storage spaces. Two types of glazed tiles are used on wall surfaces. The variety of those glazed tiles are most probably because of later interventions. However, this wealthy room in terms of spatial organization, architectural characteristic and ornamentation, clearly shows the structural problems, physical deteriorations, later interventions and the clues of previous phases of the building. Besides, on the northeast

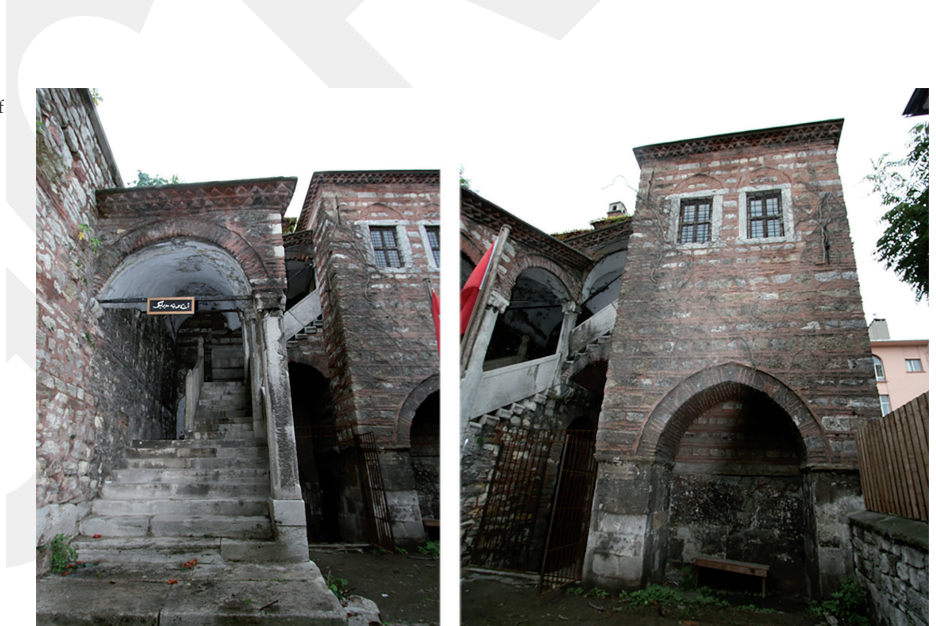
Figure 12. The Northwest Façade, 2012.

After arriving at the garden from the gate on the Şehzade Mosque Street, northwest façade of the library is firstly seen (Figure 12). Three types of masonry are observed on this façade. The prevalent wall type is Type C, which is common for two blocks; Type B is observed in the lower parts; and the other wall masonry type is Type F that can be seen from the staircase stuck to the northwest façade of the main reading hall (Figure 13). For some reason, this wall looks like as ornamental wall and the pattern of this part is different from the rest. There are rounded limestone blocks, which rise from the wall and the staircase is stuck in this wall, which is very contradictory situation. Because, it is not a common thing to put a staircase in front of this kind of ornamental wall in the first planning. Therefore, it is possible to claim that the staircase was added later than the first construction in the past, but not very close to today. Another important detail should be mentioned is an arch and a niche at the lower side of the front block; Type A masonry is detected and inside the niche, there are two

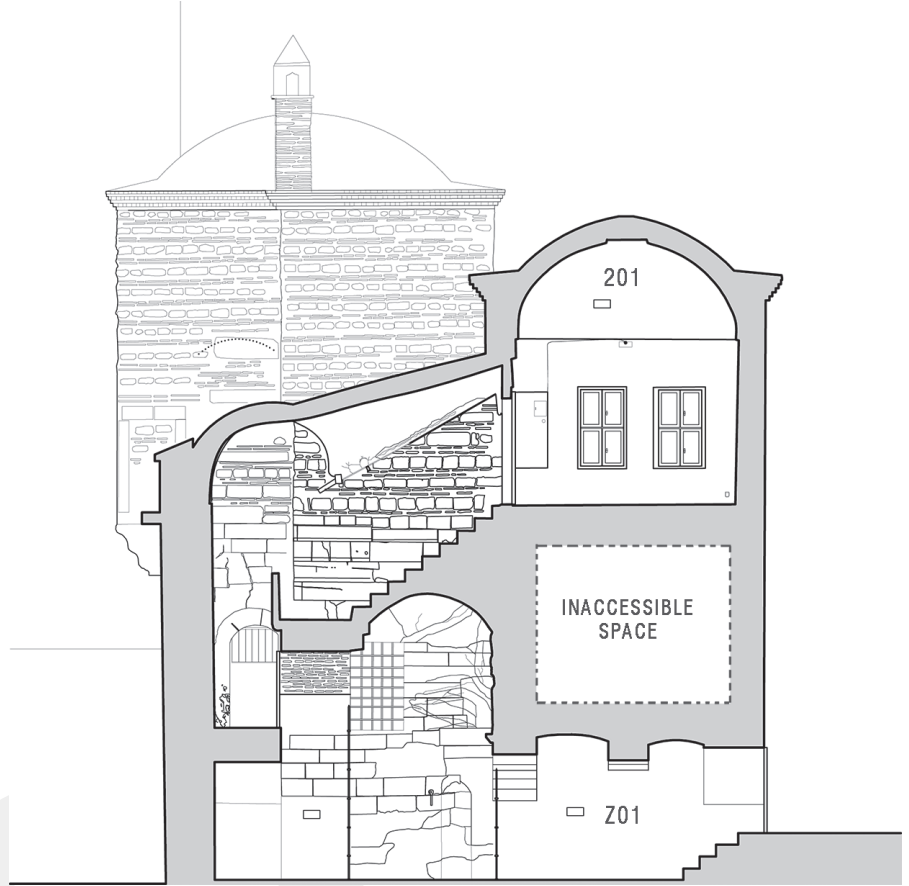
Figure 14. Şehit Ali Paşa Library Section-2, 2012.

arches and a fountain hole, which does not work today. Above the niche, there is an inaccessible space, which is quite stimulating to consider (Figure 14). The functional theory of this space will be discussed in the third section.

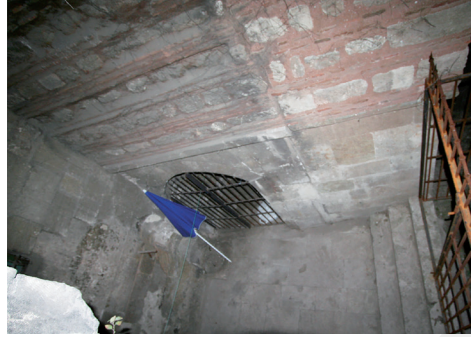
Figure 16. Southwest Façade, 2012.

On the southwest façade of the library, three types of masonry are observed; Type B, Type C and Type D (Figure 16). Mainly, limestone blocks are used in construction of the lower part of this façade, but the southeast corner of the smaller block, there is an area constructed in Type C, which is considered as an intervention in the past. According to the photographs dated 1971, this building was repaired and the cement part, which was an inappropriate intervention in the past, was replaced the original fabric the decision of Directorate of Foundation (Figure 17b). Alternating wall masonry of southwest façade consists of two rows of brick and a row of stone. The lower part of the main reading hall, there are two types of material; limestone and *Od Taşı*, which is known its resistance to fire. Thus, it would be a repair as a result of a fire as indicated in the inscription. Besides, there are six windows and a dovecot with limestone edges on this facade and five of the windows have limestone window frames in spite of one of them has *Od Taşı* window frame, which probably could be replaced during a repair in the past. In addition, above the windows on the smaller block, there are brick-filled relieving arches and three rows of brick and cut stone blocks are placed on the upper parts of the main reading hall (Figure 16).

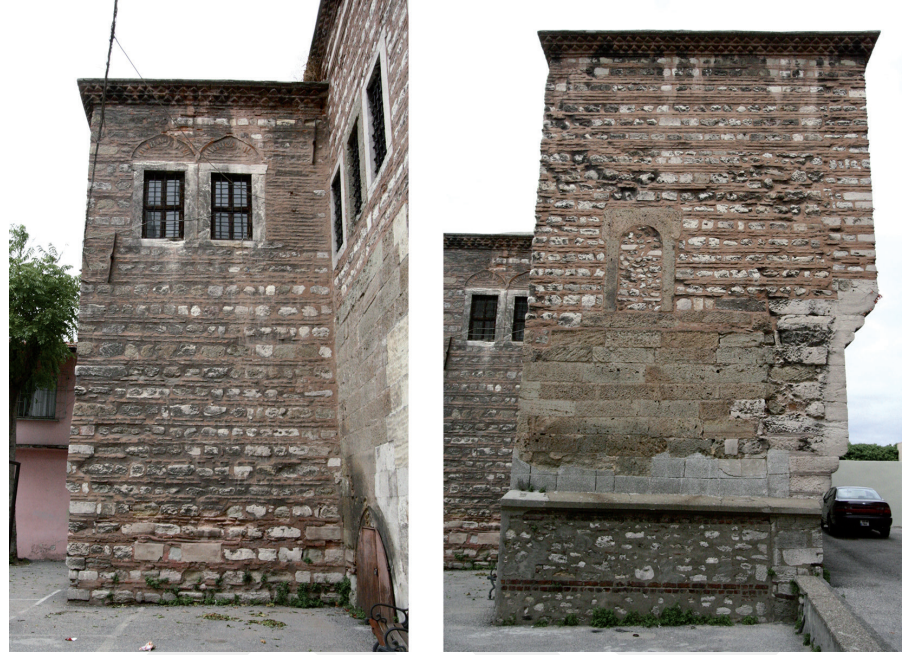
Figure 18. Southeast Façade, 2012.

Type B, Type C, Type D and Type E wall masonry types are observed on the southeast façade. The larger block was completely built in alternating wall masonry. Besides, there are two windows with limestone window frames and above them there are brick-filled relieving arches. On the upper part of this wall, partial brick masonry wall is seen, which is most probably a partial repair (Figure 18). The lower part of the wall is built in rubble stone masonry with cement mortar, which indicated that this part of the wall is more recent than the upper parts; in the middle part of the wall is Type D. The northeast corner of the façade, there are limestone blocks and the ornamental stone profiles are quite distinguishable from that view. Above Type D masonry part, a door case, which was filled with brick and stone, is considered as a clue for the restitution proposals.

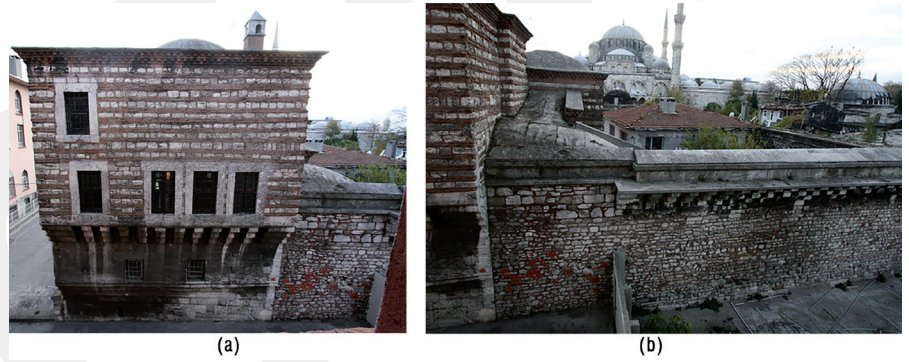
Figure 19. (a) Northeast Façade, (b) Garden Wall and Load-Bearer Stone Projections, 2012.

The northeast façade of the library is the most spectacular one in compared to the other façades; because there are load-bearing ornamental stone elements starting from the southeast corner to the end of the garden wall (Figure 19a), (Figure 19b). The northeast façade consists of two types of masonry; Type B and Type C. The basement and the first floor of the library were constructed in cut stone masonry with limestone blocks and at the bottom of the windows, rounded stone profiles are observed. Second floor wall was built in Type C, alternating wall masonry, and there are five windows with limestone window frames. The projection of the second floor is carried by the load-bearing stone elements. The wall between the north corner of the library and the point that the stone profiles of the garden wall start was demolished in the past and was repaired in 1970s. However, there is something different in the wall fabric, which will be explained in the following section.

with the garden wall intersecting the other wall as a part of Süleymaniye Aqueduct (**Figure 19b**). The projections, are built for structural reasons as a load-bearer element, but also have aesthetical concerns. Therefore, continuity of the stone projections for just aesthetical reasons is not logical. It could be considered as a substructure for a building, but any proposals were not submitted in the restitution to avoid assumption due to finding no evidence or document about it. Only, documents obtained in research process for these projections tell that the garden wall was collapsed and it was repaired according to the records of Directorate of Foundations (**Figure 17a**). On the other hand, after the survey, the trace of an arch was exposed due to the leaf cast in fall. This arch could be seen from the photographs dated 1971 in the archive of Directorate of Foundations. Interestingly, this arch is very close to the upper level of the vault covering the staircase. It can be interpreted as there was an opening, a window or a door on the northwest façade and it was filled with brick and stone in the past and the staircase and vault were built afterwards. Going back to the projections, there is a gap between the projections where the building ends at the northwest corner. In this part of the garden wall, the texture is different from the rest and this difference can be seen in the photographs dated 1971. It means that there was a repair or change in the past considering the façade characteristic, and the situation of the entrance gate in the northwest garden wall on the Şehzadebaşı Street is suspicious. As noted by Şahin (2009a), the street façade was emphasized with projections and had wide windows in the 18th century Ottoman libraries. If this façade was designated as the main façade of the library, it is claimed that the entrance gate has been located on the northeast garden wall and removed at an unknown time in the past.
