The seismic behaviour of RC exterior shear walls used for strengthening of intact and damaged frames

Abstract

Keywords Cyclic loading · Exterior shear wall · Frame · Seismic behaviour · Strengthening

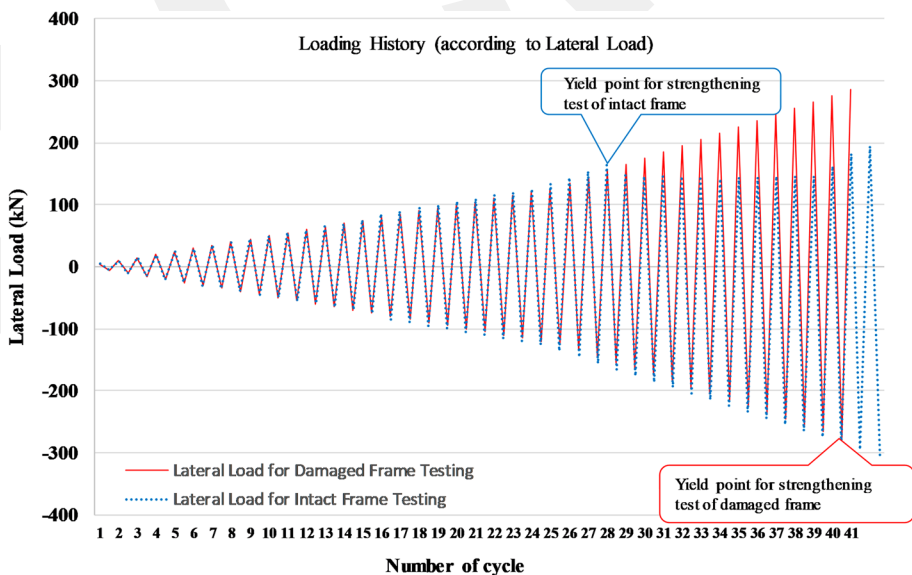
Fig. 6 Loading history of strengthening tests according to lateral load

in the elastic range for the first few cycles. The lateral load was increased by 5 kN in each cycle up to the 26th cycle and continued in 10 kN increments as load-controlled loading. In further cycles, the load was increased beyond the ultimate load level where the frame system reached yield point. After reaching the ultimate load-carrying capacity, deformation-controlled loading was applied with drift increments until the end of the tests. Loading histories based on lateral load and displacement are given in Figs. 6 and 7, respectively. At the end of each cycle, newly initiated cracks and crack propagations were marked on the frame and shear wall specimens. In addition, failure mechanisms were observed during the experiments.

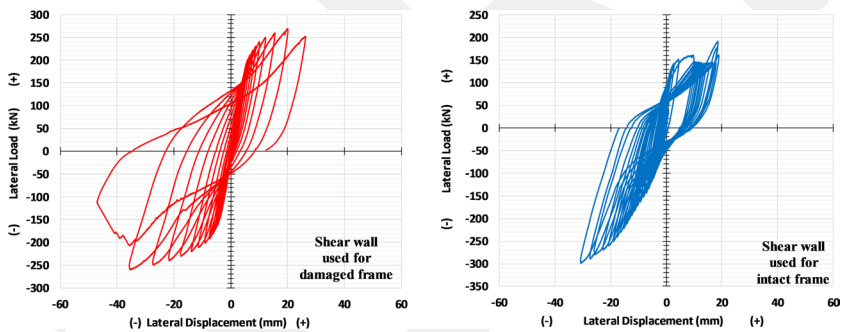
Fig. 8 Hysteresis curves of external shear walls used in both strengthening tests

The performance of the shear wall specimens was evaluated through measuring the displacement and load by the LVDT, potentiometer, and load cell. For the strengthening application, two shear walls on one foundation were tested in each experiment. In the first test, external shear walls integrated in the damaged frame via steel tie beams for strengthening application were performed under reversed cycling loads. Identical external shear walls were applied to the intact frame via steel tie beams were carried out in the second test. All the results and observations refer specifically to the shear walls. After all testing, the obtained hysteresis curves, which were used to determine the strength and stiffness characteristics of the test specimens and evaluated the general behaviour of structural members, for both tests are shown in Fig. 8.

As seen in the graphs, the maximum strength of the external shear wall used for the damaged frame strengthening test was 269.55 kN while the maximum displacement of the

shear wall was 35.48 mm. On the other side, the external shear wall used for intact frame strengthening reached 299.12 kN and 30.703 mm, as maximum strength and displacement, respectively. By comparing the results, the maximum strength of the shear wall used for strengthening of the intact frame was higher than the shear wall used for strengthening of the damaged frame. The maximum lateral displacement reaching by external shear wall used for intact frame was lower than the shear wall used for the damaged frame.

As seen in Fig. 8, during the elastic behaviour of the strengthening system before the yielding limit, the displacements in the push and pull cycles were close to each other. The displacement differences in the push and pull cycles became more significant during the inelastic behaviour after the yielding limit. Therefore, the displacement differences between the push and pull cycles were numerical quantities that might arise due to the effect of plastic hinges, which occurred during the push and pull cycles. In addition, the symmetries of curves obtained from the strengthening test were distorted due to the differences

in interaction between the shear wall behavior with high rigidity and frame behaviour with low-rigidity. This is because the moment of inertia of the steel tie beam was selected to be less than the frame and external shear wall to increase energy consumption and it provided the ductile behaviour of the strengthening system. Since the load distribution was affected in the pull and push cycle due to the low moment of inertia of the steel tie beam, the symmetry in the curve was distorted.

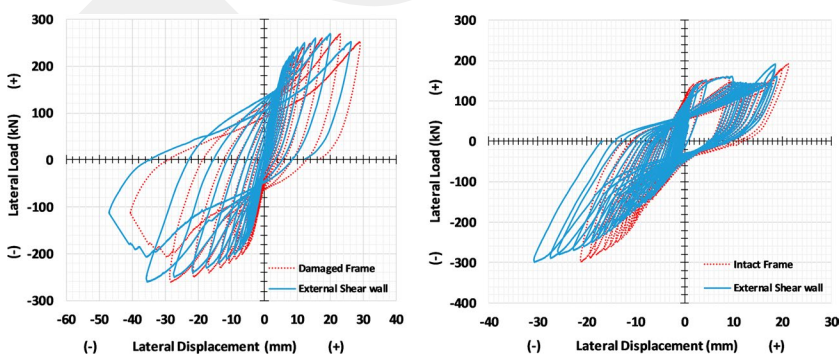
Fig. 9 Lateral load–displacement curves for the distribution of lateral load between frames and external shear walls in the damaged frame and intact frame strengthening tests, respectively

The lateral load acting on both frame and shear walls was measured by the load cell while the lateral displacements of the frame and shear wall were measured by the potentiometer and LVDT located at the joint of the frame and shear wall along the same axis. The applied lateral load transferred from the frame to shear walls in the pull and push cycles with the help of the transmission shafts. The measurements obtained from these points are shown in Fig. 9 as lateral load–displacement curves. According to the results, the lateral load level acting on each of the shear walls was the same as the frame specimen in each strengthening test. In addition, the horizontal part of the curves in the hysteresis diagram was observed due to permanent displacement that was caused to occur by crack development.

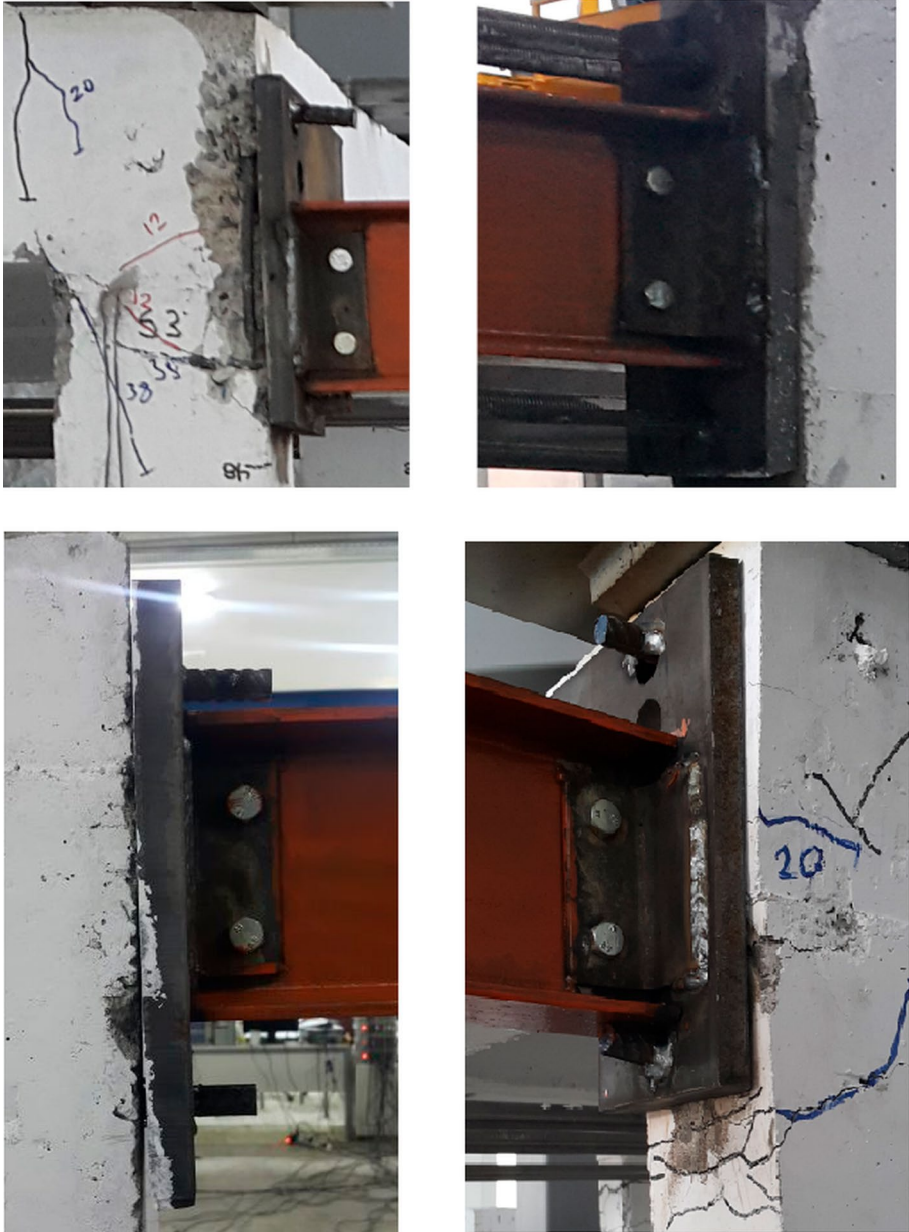
Fig. 12 The anchors for the steel tie beams in the damaged frame strengthening test

It was checked whether the anchors connecting the frames and external shear walls with steel tie beams peeled or opened during the experiments. During these inspections, especially after the 30th cycle in the damaged frame strengthening test, due to the work of the anchors of the steel tie beams connecting the frames and external shear wall, crack intensity increased in the column-beam joint section and some peeling was observed in the anchors

(Fig. 12). Some microcracks occurred in the same section of the intact frame strengthening test but the intensity of the cracks were less than those of the damaged frame strengthening test. Nevertheless, there was no damage in any steel tie beams in the strengthening tests.

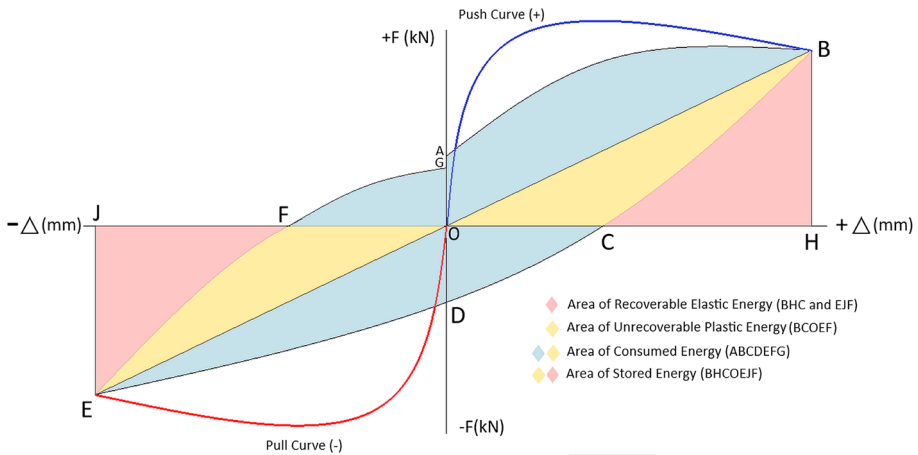
Fig. 15 Energy consumption zones (Dirikgil and Atas 2019)

The energy dissipation capacity of structural system components is an important indicator affecting the behaviour of structures in earthquakes. Structural members with plastic behaviour dissipate some energy per cycle of loading. The concepts of energy dissipation and stored plastic energy are related to elastic and plastic straining theorems, the heterogeneous nature of deformations, and cracks in the micro-mechanical level. The energy terms are categorized into elastic and plastic energy in the structure during reversed cycling loading (Collins 2005). Elastic energy is recoverable when it unloads to original imposed stress conditions represented by the pink shaded area in Fig. 15. Although stress changes in the micro-mechanical level, elastic straining at that level is not likely to be recovered. This energy is called unrecoverable plastic energy when considering macro-mechanical behaviour. For reversed cycling loading, the energy dissipation rate was evaluated from the area under the envelope curves plotted as the measured load versus displacement curve. The term consumed energy means unrecoverable mechanical work, which was supposed to include all irreversible parts of the work done, was calculated by the total area under the A, B, C, D, E, F, and G points in Fig. 15. The energy stored in the structural member is defined as stored energy by adding up recoverable elastic energy and unrecoverable plastic energy (Fig. 15).

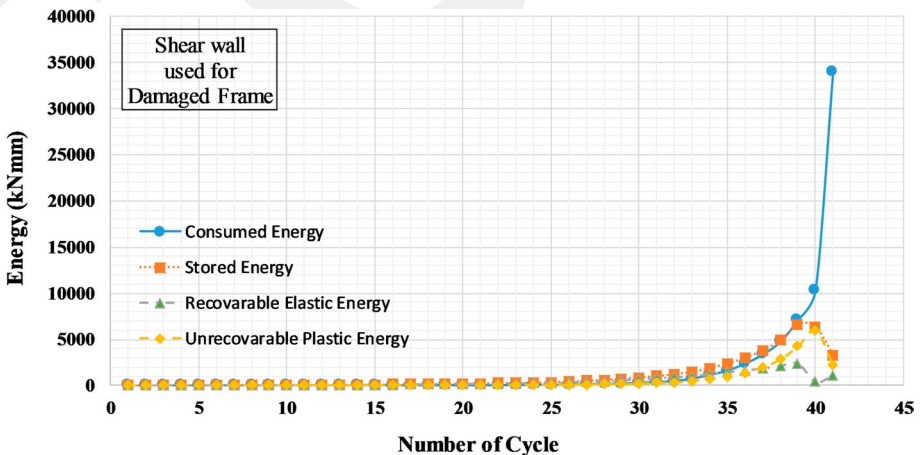
Fig. 16 Energy values of the shear wall used in the strengthening test of the damaged frame

As seen from the graphs, the amount of consumed energy of the shear wall used for the strengthening of the damaged frame was calculated as 68,084 kN-mm, whereas the same energy value was obtained as 42,173 kN-mm for the shear wall used for the intact frame. The stored energy was determined as 42,212 kN-mm while it was calculated as 54,372 kN-mm in the strengthening test of the intact frame. Moreover, the amount of elastic energy of the shear wall used in the testing of the damaged frame was 19,629 kN-mm while the amount of plastic energy was 22,583 kN-mm. Otherwise, the amount of

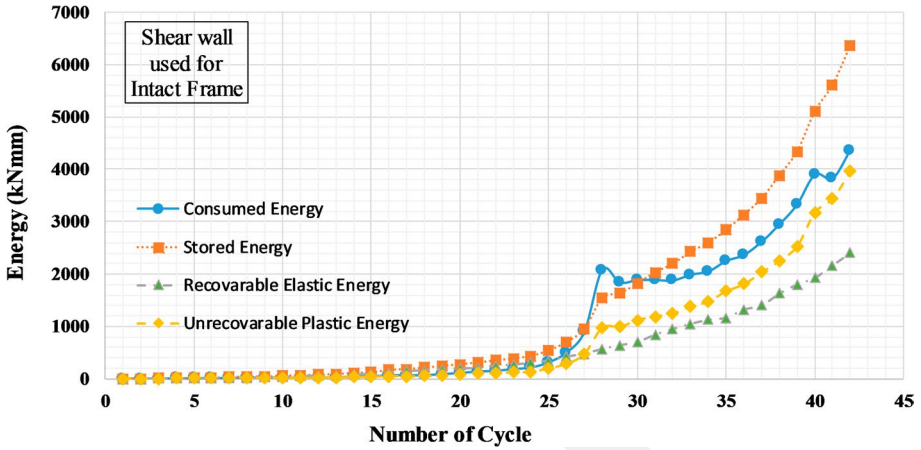
Fig. 17 Energy values of the shear wall used in the strengthening test of the intact frame

elastic energy of the shear wall for the strengthening of the intact frame was calculated as 23,241 kN-mm and the amount of plastic energy was estimated as 31,131 kN-mm.

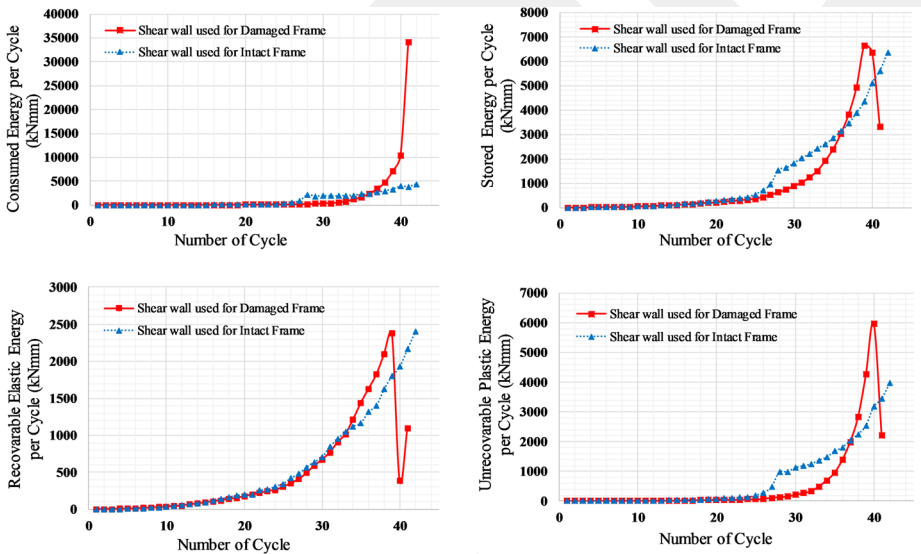
Fig. 18 Energy values of the shear walls used in the strengthening test

calculated by adding the energy dissipated in successive cycles during the test. In addition to this, the calculation of the energy stored per cycle, the recoverable elastic, and unrecoverable plastic energy per cycle for each specimen are shown in Figs. 16 and 17. In addition, the amounts of the energy per cycle of shear wall in both tests are given in Fig. 18, comparatively.

The consumed energy per cycle of the shear wall used for the damaged frame was 148.22% higher than the shear wall used for the intact frame. The amount of stored energy per cycle of shear wall in both tests was close as expected in the last cycle, where the stored energy of the shear wall used for the damaged frame dropped suddenly due to a failure mechanism. Recoverable plastic energy per cycle was similar in each test but identically, in the last cycle, there was a sudden drop in the strengthening of the damaged frame testing. However, it was observed that the unrecoverable plastic energy per cycle of the shear wall

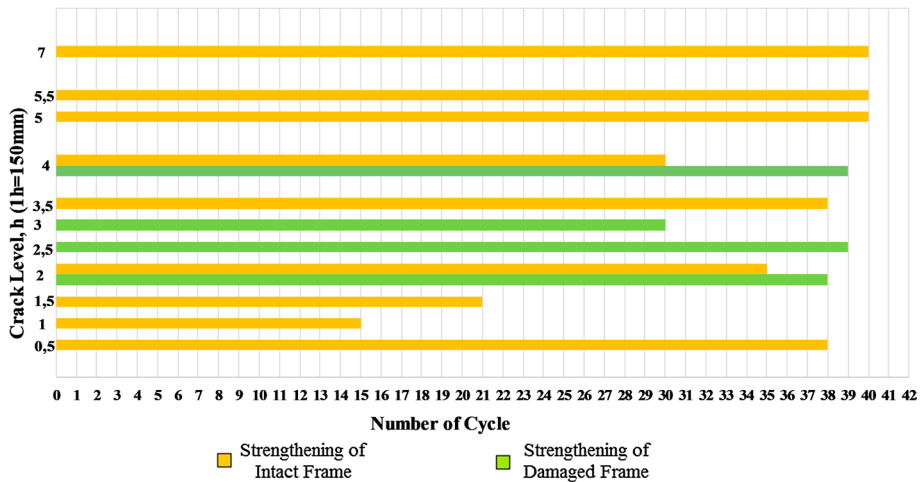
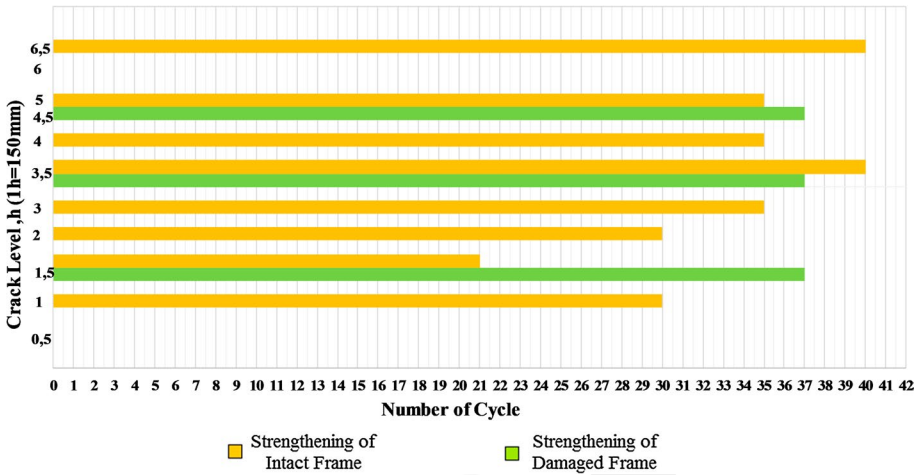
Fig. 20 Crack propagation on the pull face of the front shear wall

Fig. 21 Crack propagation on the push face of the front shear wall

Fig. 22 Crack propagation on the pull face of the back shear wall

Fig. 23 Crack propagation on the push face of the back shear wall

During both tests, flexural crack patterns on the push and pull faces of all external shear walls were observed. Opening in the shear wall-base joint occurred in further cycles as the width of the opening expanded and then turned into significant separation. As a result, the external shear walls failed. It was determined that the failure mechanism was shear failure due to a collapse, which had occurred at the baseline of the shear walls. According to a comparison between the strengthening of damaged and intact frames via external shear walls, the first crack patterns on the external shear walls appeared in the strengthening of the intact frame. However, an opening along the baseline of the shear

wall occurred in further cycles. In addition, the crack density on the external shear wall used in the strengthening of damaged frame testing was more than in the strengthening of intact frame testing. Although buckling in the longitudinal reinforcement at the wall-base junction area of the external shear walls was observed in the two strengthening tests, the amount of buckled reinforcement bar of the shear wall in the damaged frame test was higher than the intact frame test. As the amount of buckled longitudinal reinforcement bar in the wall-base junction area increased, most of the reinforcement bar located in this joint area suddenly ruptured. Because of rupturing in the reinforcement bar, friction shear strength decreased and shear failure mechanism appeared as shown in Figs. 20, 21, 22 and 23. In the study, each shear wall was divided into 10 intervals (each interval was 150 mm) represented as ‘h’ from the bottom to the top to monitor crack

formation. This is seen in Fig. 5. Figures 20, 21, 22 and 23 shows the cracks, which appeared in these interval levels represented by ‘h’ on the shear wall faces.
