One-Story Three-Dimensional Frame Structures Behavior Strengthened with External Shear Wall under Cyclic Loading: An Experimental Study

Hurmet Kucukgoncu & Fatih Altun

^aDepartment of Civil Engineering, Abdullah Gül University, Kayseri, Turkey; ^bDepartment of Civil Engineering, Erciyes University, Kayseri, Turkey

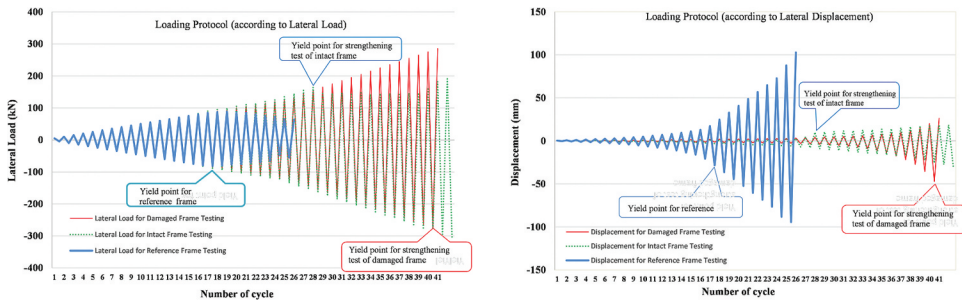
Figure 6. Loading protocols for all tests with respect to a) lateral load b) lateral displacement.

One of three constructed specimens, a bare frame was tested at first as a reference test. Then, another identical frame was tested to make the frame damaged until pre-determined damaged levels with respect to the drift ratio. There was about 2.6% drift ratio at the end of the test, and the damage level of the frame was called ‘Marked Damage Region’ as stated in the Turkish Earthquake Code 2007 (TEC 2007). This damage level with a drift ratio is mentioned in the Federal Emergency Management Agency (FEMA) as either ‘Life Safety (LS) Structural Performance Level’ or ‘Limited Safety Structural Performance Range’ and defined as the continuous range of damaged states between ‘Life Safety’ and the ‘Collapse Prevention Structural Performance Level (FEMA356 2000). Finally, damaged and undamaged frames were tested by adding exterior reinforced concrete shear walls with steel tie beams, respectively. During each test, in both push and pull half cycles, a 5 kN lateral load was applied at the beginning. In the reference frame test, the lateral load was increased by 5 kN in each cycle as far as the frame was capable of resisting higher loads, and deformation-controlled loading was applied due

to increasing displacement values in cycles. Similarly, in the strengthening test, the lateral load was increased by 5 kN in each cycle up to the 26th cycle and then continued in 10 kN increments as load-controlled. After reaching the yielding stage, deformation-controlled loading was applied until the end of the test. Loading protocols with respect to the lateral load and lateral displacement are given in Fig. 6. Applied vertical and lateral loads were measured by two load cells. The loads were continuously monitored, and the lateral load-top displacement curve of the test frame was plotted during each test. All cracks in the frame and shear walls were marked and the failure mechanism was observed during the tests.

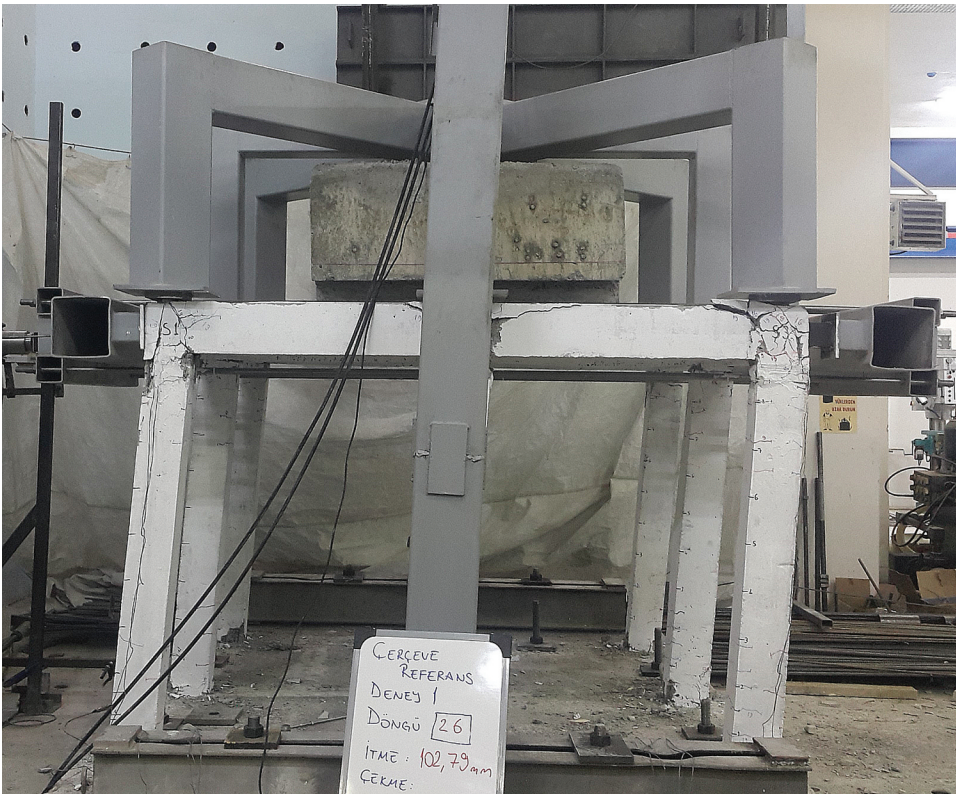
For reference frame specimen RF, the first flexural cracks were recorded at the (1 h) level on the S101 column and the (8 h) level of the S104 column at a 20 kN load level. In the S105, S106, and S109 columns, the first flexural crack formations were observed in the beam-column joints. The first flexural crack in the beams occurred in K106, while the first crack was noted in the D102 slab. The first flexural-shear crack in the base-column joint was observed in the S101 column at a 65 kN load level. According to the crack monitoring during testing, the most damaged members were the columns, whereas the most damaged regions were the beam-column and the base-column joints. Buckling in reinforcements located in the base-column joint occurred. The test was completed at a 63 kN load level by a 6.85% drift due to the load level decreasing by 30%. During the following loading cycles, the intensities and widths of the cracks between the bottom of the columns and the beam-column joints increased. The reference frame at the end of the test is given in Fig. 7.

Figure 7. The reference frame at the end of the test.

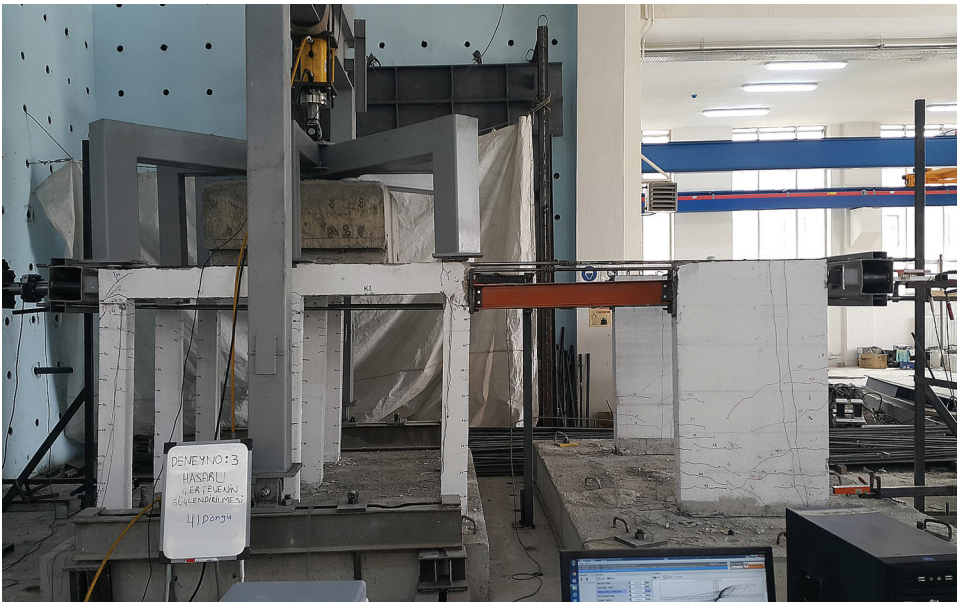
In the third test, the second specimen damaged in the second test was strengthened with external shear walls. The first flexural cracks were observed at a 35 kN load level both at the (6 h) level of the S101 column and (4 h) and (7 h) levels of the S107 column. In addition, at the same load level, the first flexural-shear crack occurred in the S102 base-column joint. At a 60 kN load level, the first crack was noted in the S103-K102 beam-column joint in a flexural-shear crack pattern, while the others were noted in the S101-K101 and S102-K101 beam-column joints in an X-pattern. The first flexural crack in the beams was advanced in the K105 beam at a 100 kN load level during the 12th cycle. For the external shear walls, the first shear crack occurred at the (1.5 h) level of SW1 at a 195 kN load level during the 32nd cycle. At the end of the 39th cycle, the opening enlarged significantly. Then, the longitudinal reinforcements in that area ruptured when the shear cracks opened widely, and the strength of the specimen suddenly decreased. The appearance of the strengthened damaged frame at the end of the test is presented in Fig. 8.

Figure 8. The appearance of the strengthened damaged frame at the end of the third test.

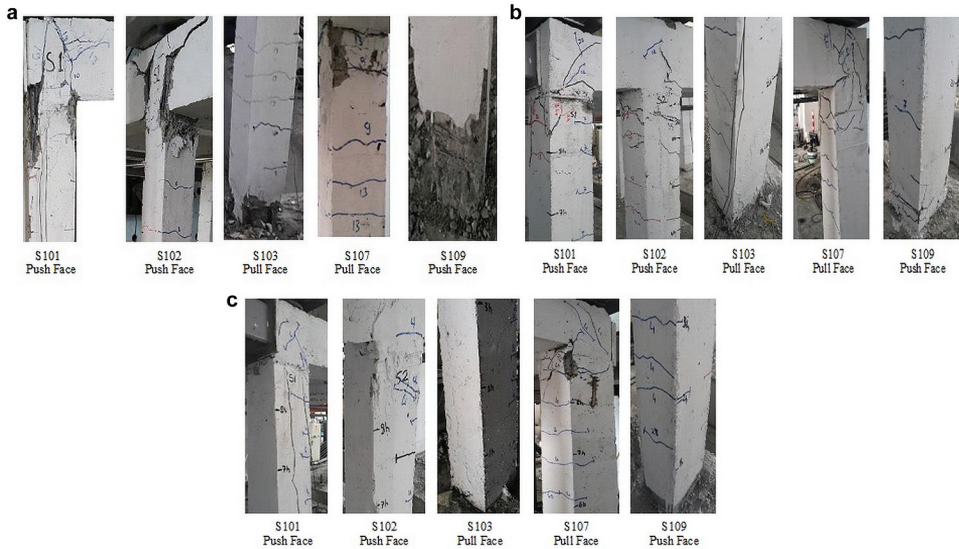
Figure 10. (a) Damage appeared in some columns of the reference frame at the end of the test. (b) Damage appeared in some columns of the strengthened damaged test frame at the end of the test. (c) Damage appeared in some columns of the strengthened undamaged frame at the end of the test.

For the RC frame specimens, the formation of the first flexural cracks in the columns occurred in the first and fourth tests in earlier cycles compared to the other experiments. The first horizontal flexural crack formation in the base-column joint observed in the strengthening test of the undamaged frame was the earliest, while it was the latest in the reference test. The first flexural-shear crack in the beam-column joints appeared in the strengthening test of the undamaged frame during the earliest cycles, whereas in the latest cycles in the strengthening test of the damaged frame. The intensity and the width of flexural cracks increased with incremental load significantly. Although the shear cracks in the columns propagated from the beam-column and base-column joints to the mid-sections of the

column by increasing horizontal load, no crack formations in most of the columns were observed between the (3 h-6 h) level on the pull faces and (4 h-6 h) level on the push faces during all testing. Moreover, the ratio of non-cracked areas in the middle section of the column increased, especially in the undamaged frame because of the addition of the shear walls to the structural system. The first flexural crack in the beams developed in earlier cycles with the addition of the shear walls to the system, but it was observed that the crack intensity decreased by strengthening the frames. Since the frame specimens that were defective and weak in terms of earthquake resistance were investigated, the first flexural cracks in the beams occurred before the yield load due to the mechanism and plastic hinge during all tests. Although most of the crack patterns observed in the columns, beams, and joints were flexural cracks, some shear cracks appeared in column members and column-beam joints. However, no torsional crack was observed in any element during all the tests. The most damaged columns of the reference frame at the end of the reference, strengthened damaged and undamaged tests are illustrated in [Fig. 10](#). The flexural cracks occurring in beams due to tensile forces and bending moments generally were observed in the lower and upper faces of the beams in the areas closest to the supports. Compression failure occurred because of crushing in the concrete of the base-column joints. Additionally, buckling in the longitudinal reinforcements of the columns was observed, and a plastic hinge appeared at the bottom of the column. Furthermore, significant damage appeared in the reference frame before and after the maximum load, but no significant damage and cracks occurred in the strengthened frames at the maximum load level. As shown in [Fig. 10](#), the crack intensity and the width in the strengthened frames decreased due to the addition of shear walls.

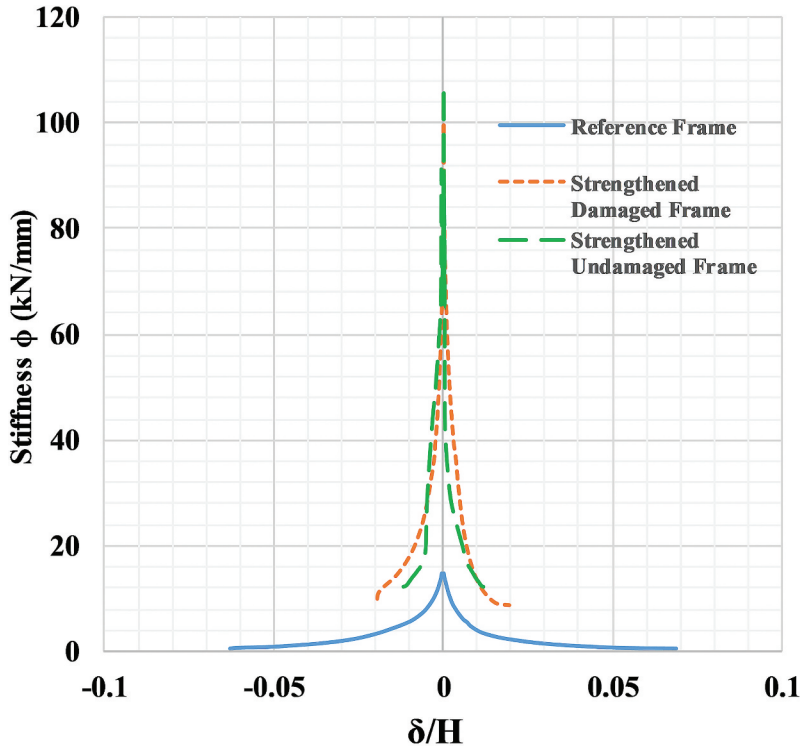
According to Table 4, the strengthened damaged and undamaged frames had higher initial and maximum lateral loading stiffness values than the reference frame did. The stiffness degradations of all specimens are given comparatively in Fig. 14.

Figure 14 also shows that all the stiffness values of the strengthened frames were higher than the stiffness of the reference frame. Thus, adding shear walls to the frames for strengthening considerably

Figure 14. The comparison of the stiffness degradations curves of all specimens.

increased the rigidity of both the frames and the system. Additionally, it was observed that the stiffness of the undamaged frame was higher than the stiffness of the damaged frame by comparing the strengthening tests. The reason was that the strength and the rigidity of the undamaged frame were higher than the damaged frame and the stiffness values of the shear walls added to the frame had similar behaviors to the frame.

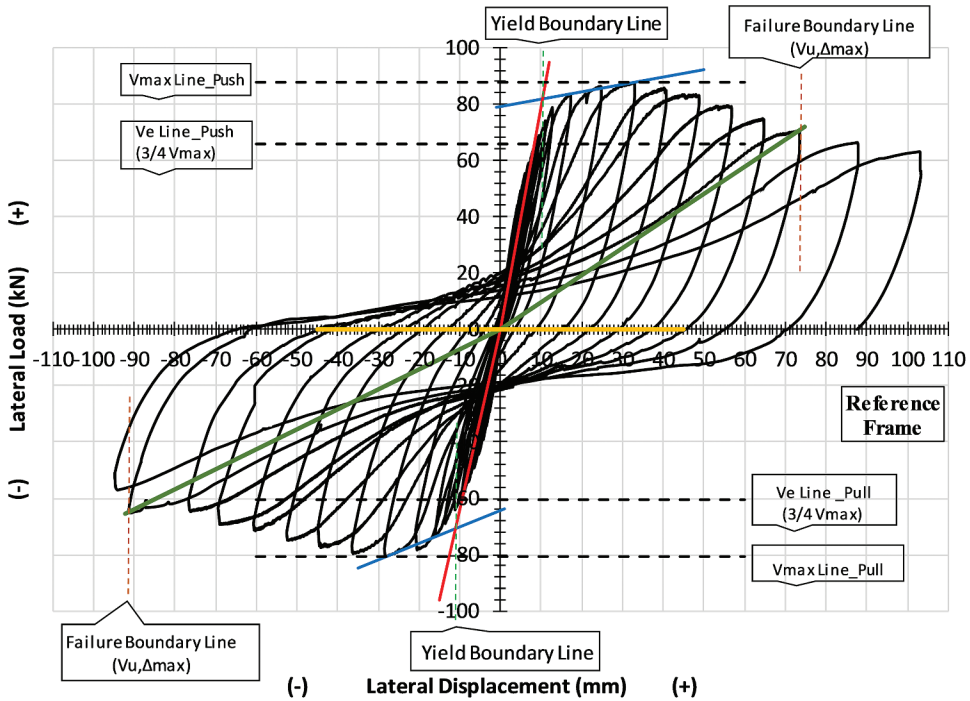
A graphical method was used to reach the displacement ductility values of the frames with the help of envelope curves obtained from the hysteresis curves. After the envelope curve was drawn, the maximum lateral load point (F_{max}) and the corresponding displacement point (Δ), were marked in the forward and backward cycles. Then, the displacement point where the maximum load decreased by 25% was marked as Δ_1 on the envelope curve. Both the coordinates of the peak point of the cycle (F_{max} , Δ) and the peak point of the cycle before two cycles (F_{max-2} , Δ_{max-2}) were marked on the envelope curve. Moreover, the displacement value corresponding to the intersection point of the curves where a 25% decrease in lateral load with the tangent drawn to the envelope curve was obtained as Δ_2 . In addition to the displacement point where the maximum lateral load (F_u) decreased by 20%, was obtained and named as Δ_{max} . Finally, the yield displacement value Δ_y was determined using these load and displacement points on the envelope curve graphically (Fig. 15). Thus, the displacement ductility values of the test specimens were calculated for both the push and pull cycles by using Eq. (2) as following (Dirikgil and Atas 2019);

Figure 15. The scheme of the displacement ductility calculation diagram for the reference test specimens.

The maximum displacement, yield displacement, and displacement ductility values of the test frames are given in Table 5. In addition, the mean displacement ductility values were calculated by using the values of the push and pull cycles for better comparison. In comparison with all frames, the highest displacement ductility value was obtained from the reference frame. Additionally, it was observed that

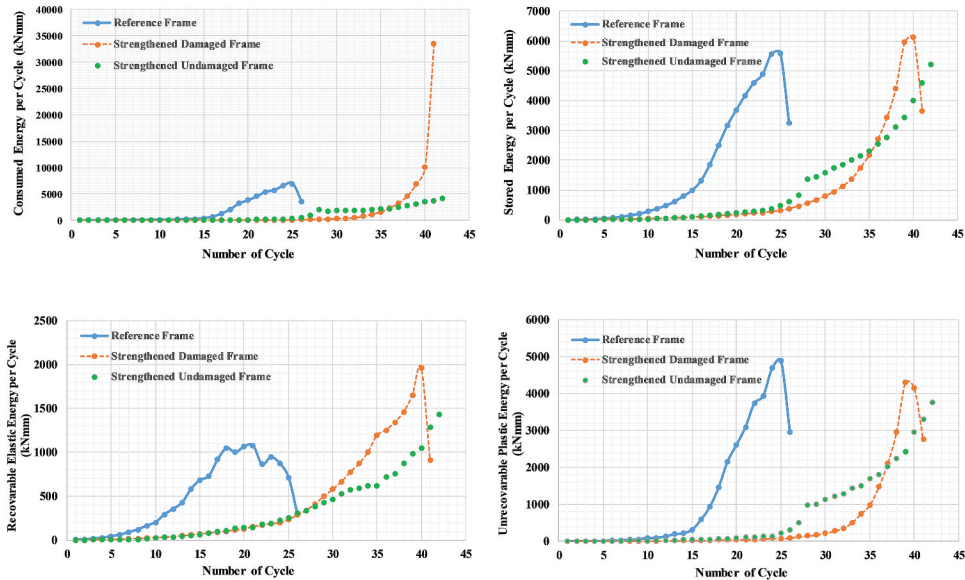
Figure 16. The energy values of the test specimens.

The amount of energy dissipation of the reference frame was calculated from Figs. 16 and Figure 17 as 45195 kN.mm, while the same parameter was higher by 148.22% at 66989 kN.mm for the damaged frame strengthened by external shear walls. On the contrary, it was observed that the result of the undamaged frame strengthened by external shear walls was close to the reference frame, even if it was lower by 11.81% at 40420 kN.mm. It was supposed that the highest amount of energy consumption would be observed in the reference frame because of its ductile behavior, but the strengthened

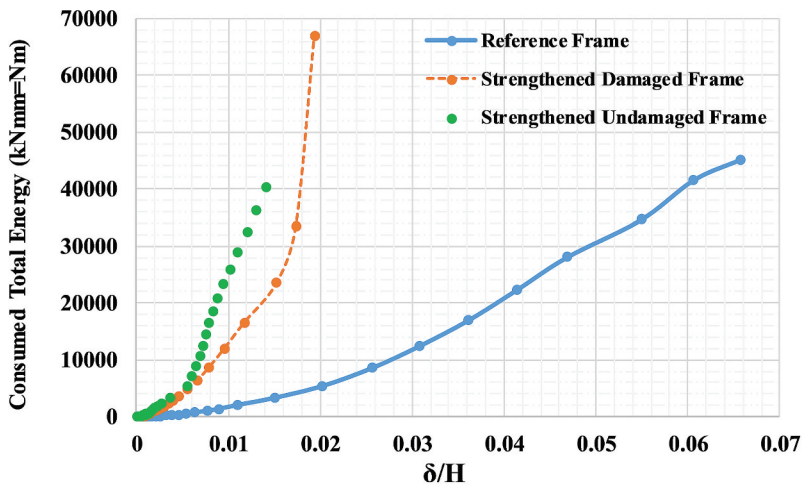
Figure 17. The consumed total energy values of the test specimens.

- Based on the test results, the damaged frame strengthened by external shear walls consumed higher energy by 148.22% than the reference frame ([Fig. 17](#)). The amounts of the consumed energy in the case of maximum lateral load calculated from the strengthened undamaged and damaged frame systems were 4.17 and 3.89 times higher than the reference frame, respectively ([Table 7](#)). Hence, the addition of external shear walls to the reinforced concrete frame for strengthening increased the energy consumption of the structural system.

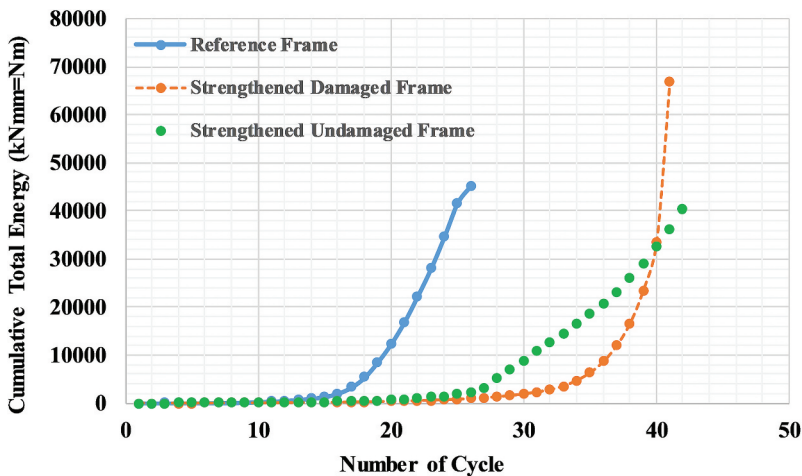
Cumulative total energy consumption values were calculated by successive summation of energy consumed in each cycle, and the graphs of the cumulative total energy consumption for all experiments are presented comparatively in Fig. 18. According to the experimental results, the amounts of energy consumption from high to low value for damaged, reference, and undamaged frame systems are shown, respectively. The results of cumulative total energy consumption were similar to the total amount of energy consumed as expected, and the increase in lateral load after a point in the push cycles in the strengthened undamaged frame experiment was considered as another reason for that case.

Figure 18. The cumulative total energy consumptions of all test frames.
