## One-Story Three-Dimensional Frame Structures Behavior Strengthened with External Shear Wall under Cyclic Loading: An Experimental Study

In this study, the seismic behaviors of strengthened three-dimensional frames, as in real-life structures, are presented. Three reinforced concrete (RC) frames, containing common structural deficiencies were constructed to represent existing older structures. The bare, damaged, and undamaged frames, strengthened by RC external shear walls with steel tie beams, were tested under a reversed cyclic load. The experimental results indicated that strengthening by external shear walls made significant contributions to the frames in lateral strength, stiffness, and energy dissipation capacity. This proposed method appears to be an efficient technique for strengthening structures in an effective, economical, and practical way.

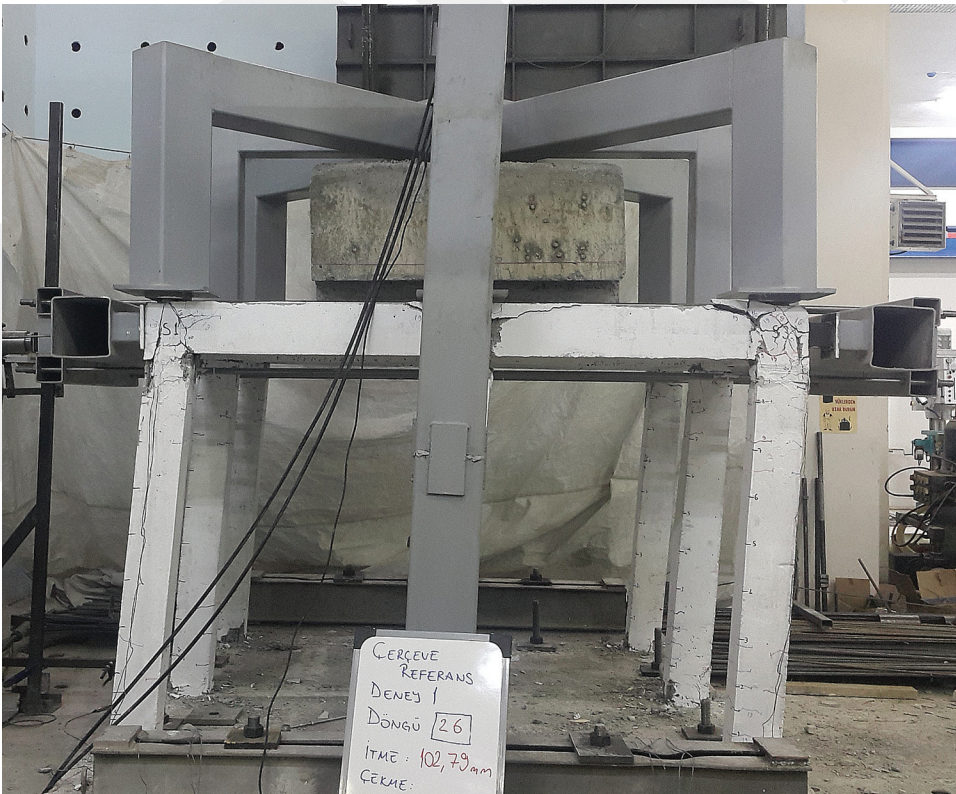
Figure 7. The reference frame at the end of the test.

For reference frame specimen RF, the first flexural cracks were recorded at the (1 h) level on the S101 column and the (8 h) level of the S104 column at a 20 kN load level. In the S105, S106, and S109 columns, the first flexural crack formations were observed in the beam-column joints. The first flexural crack in the beams occurred in K106, while the first crack was noted in the D102 slab. The first flexural-shear crack in the base-column joint was observed in the S101 column at a 65 kN load level. According to the crack monitoring during testing, the most damaged members were the columns, whereas the most damaged regions were the beam-column and the base-column joints. Buckling in reinforcements located in the base-column joint occurred. The test was completed at a 63 kN load level by a 6.85% drift due to the load level decreasing by 30%. During the following loading cycles, the intensities and widths of the cracks between the bottom of the columns and the beam-column joints increased. The reference frame at the end of the test is given in Fig. 7.

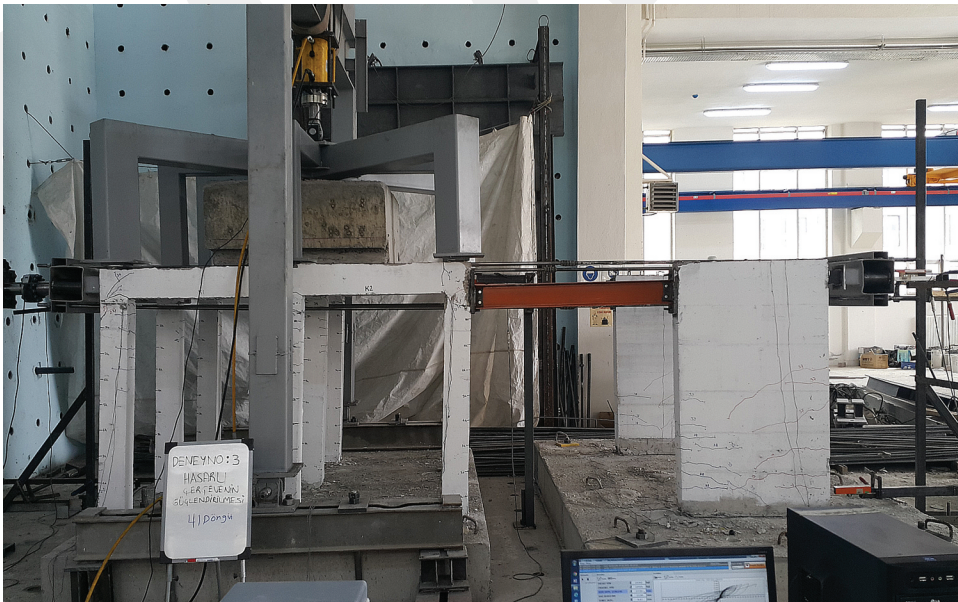
Figure 8. The appearance of the strengthened damaged frame at the end of the third test.

In the third test, the second specimen damaged in the second test was strengthened with external shear walls. The first flexural cracks were observed at a 35 kN load level both at the (6 h) level of the S101 column and (4 h) and (7 h) levels of the S107 column. In addition, at the same load level, the first flexural-shear crack occurred in the S102 base-column joint. At a 60 kN load level, the first crack was noted in the S103-K102 beam-column joint in a flexural-shear crack pattern, while the others were noted in the S101-K101 and S102-K101 beam-column joints in an X-pattern. The first flexural crack in the beams was advanced in the K105 beam at a 100 kN load level during the 12<sup>th</sup> cycle. For the external shear walls, the first shear crack occurred at the (1.5 h) level of SW1 at a 195 kN load level during the 32<sup>nd</sup> cycle. At the end of the 39<sup>th</sup> cycle, the opening enlarged significantly. Then, the longitudinal reinforcements in that area ruptured when the shear cracks opened widely, and the strength of the specimen suddenly decreased. The appearance of the strengthened damaged frame at the end of the test is presented in Fig. 8.

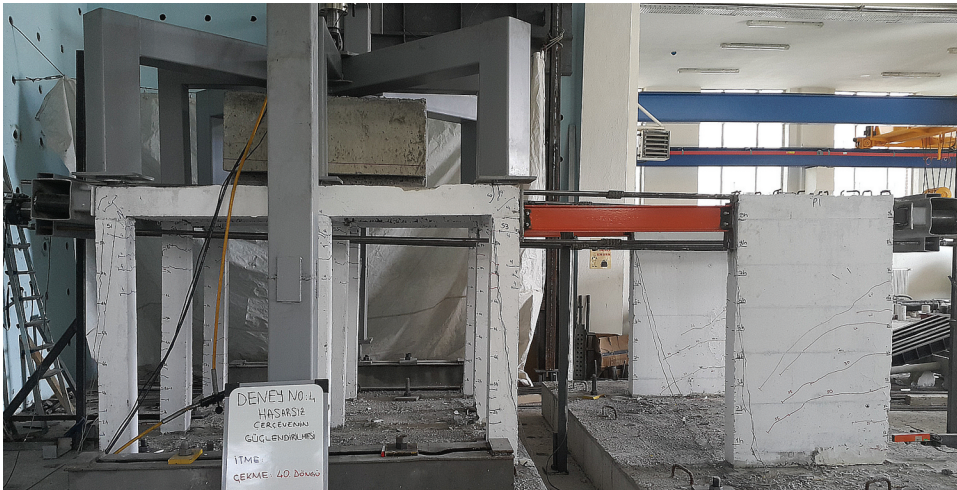
**Figure 9.** The strengthened system in the 40<sup>th</sup> push cycle in the fourth test.

The third specimen, which was the undamaged frame, was tested in the fourth test (Fig. 9). The first flexural cracks due to bending around all columns at the (3 h) and (6 h) levels and beam-column joint of S101-K101, S102-K102, S103-K102, S107-K105, and S108-K106 appeared at a 20 kN load level in the 4<sup>th</sup> cycle. During this cycle, the first flexural cracks occurred in the K101, K102, K105, and K106 beams, while the first flexural cracks in the base joint were noted in the S106 column. The first cracks in the slabs propagated in the D101 and D103 slabs at a 163 kN load level. In this test, the SW1 shear wall collapsed at 305 kN by reaching 21.22 mm as peak displacement because of the visible opening between the bottom of the SW1 shear wall and the base joint, starting from the right corner of the shear wall to the front face.

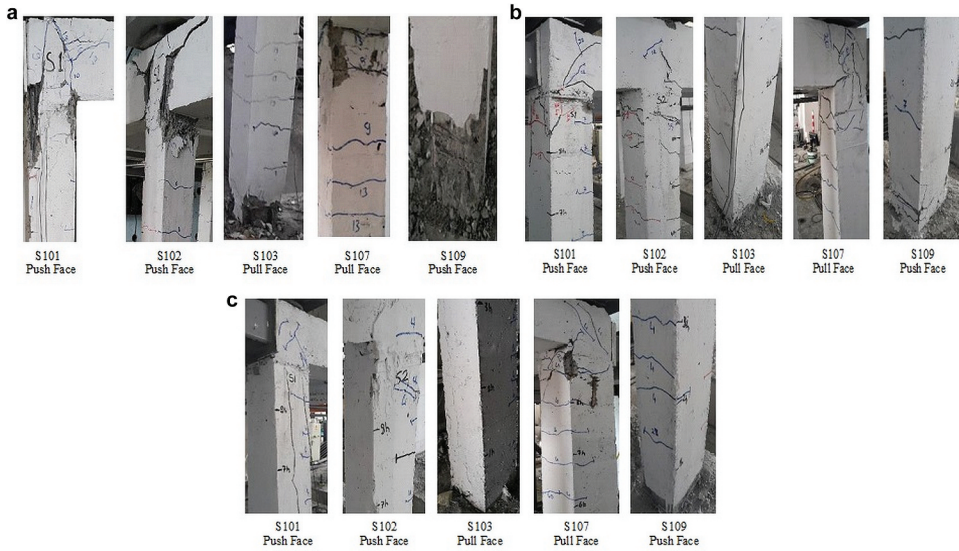
**Figure 10.** (a) Damage appeared in some columns of the reference frame at the end of the test. (b) Damage appeared in some columns of the strengthened damaged frame at the end of the test. (c) Damage appeared in some columns of the strengthened undamaged frame at the end of the test.

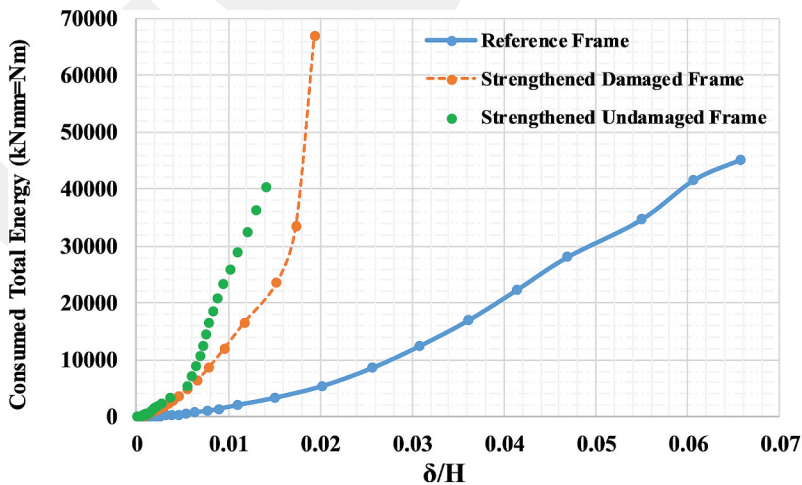
Figure 17. The consumed total energy values of the test specimens.

The amount of energy dissipation of the reference frame was calculated from Figs. 16 and Figure 17 as 45195 kN.mm, while the same parameter was higher by 148.22% at 66989 kN.mm for the damaged frame strengthened by external shear walls. On the contrary, it was observed that the result of the undamaged frame strengthened by external shear walls was close to the reference frame, even if it was lower by 11.81% at 40420 kN.mm. It was supposed that the highest amount of energy consumption would be observed in the reference frame because of its ductile behavior, but the strengthened

- Based on the test results, the damaged frame strengthened by external shear walls consumed higher energy by 148.22% than the reference frame ([Fig. 17](#)). The amounts of the consumed energy in the case of maximum lateral load calculated from the strengthened undamaged and damaged frame systems were 4.17 and 3.89 times higher than the reference frame, respectively ([Table 7](#)). Hence, the addition of external shear walls to the reinforced concrete frame for strengthening increased the energy consumption of the structural system.
