Experimental Investigation of Oblique Impact Behavior of Adhesively Bonded Composite Single-Lap Joints

Abstract

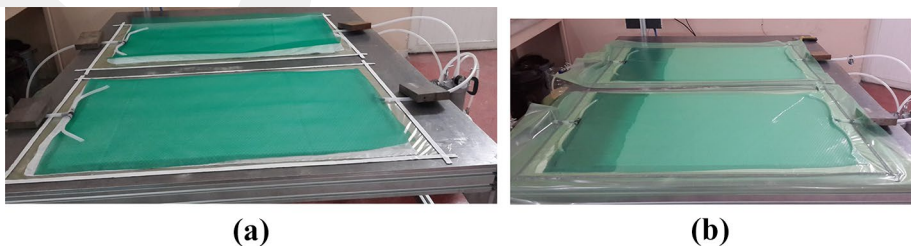
Fig. 1 Manufacturing stages of glass fiber reinforced composite: (a) placing the infusion mesh, (b) impregnating the epoxy

Glass fiber reinforced composite adherends were manufactured using the vacuum infusion method. The unidirectional glass-fiber with an area density of 600 g/m^2 and epoxy required to manufacture composite plates were obtained from Dost Chemical Industry in Turkey. In order to produce the composite material having good mechanical properties, air leaks that may occur during the vacuum process should be prevented as much as possible. For this purpose, dirt and residues that may damage the vacuum nylon were cleaned and the manufacturing process started. The manufacturing stages of the composite plate using vacuum assisted resin transfer molding (VARTM) process are shown in Fig. 1 are summarized as follows:

- On the peeling fabric, infusion mesh was laid in order to ensure the flow of epoxy resin in the vacuum nylon and spiral infusion pipes, required for the vacuum process were placed (Fig. 1a).

- Before the epoxy was transferred to the vacuum bag, the air in the bag was vacuumed by means of the pump and air leakage was checked.
- After checking for air leaks, MGS L160 epoxy resin, with hardener, was pumped into the vacuum nylon (Fig. 1b).

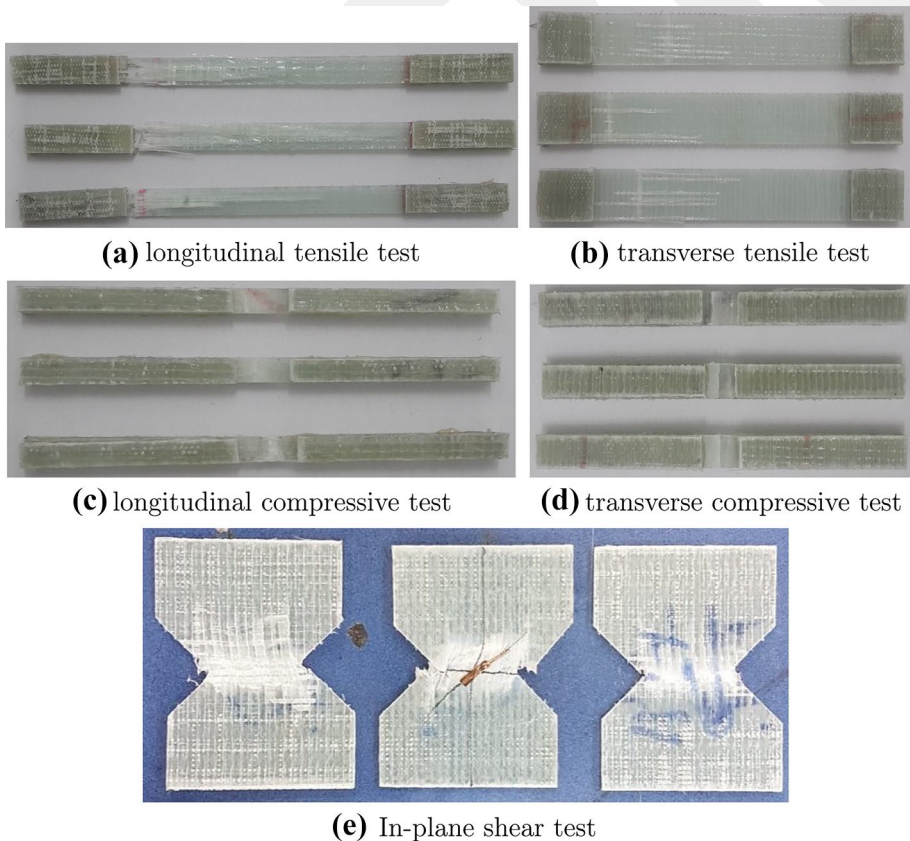
Fig. 2 The images of the glass fiber reinforced composite test specimens after the mechanical tests (a) longitudinal tensile test (b) transverse tensile test (c) longitudinal compressive test (d) transverse compressive test (e) In-plane shear test

The material properties of the composite adherend were determined by considering various test standards. Mechanical properties were determined according to the ASTM D3039-76 test standard [42] for tensile test, ASTM D3410-87 test standard [43] for compression test, and ASTM D7078-19 test standard [44] for shear test. At least five specimens were tested for each test. The images of the glass-fiber reinforced composite test specimens after the mechanical tests are presented in Fig. 2. The tensile strengths (X^T and Y^T) and the elasticity modulus (E_1 and E_2) of the composite material were determined by the tensile test. The compression strengths of the composite material (X^C and Y^C) were determined by the compression test. In addition, in-plane shear strength of the composite material was determined by the shear test. The in-plane shear modulus (G_{12}) was determined experimentally and transverse shear modulus (G_{13}) was assumed equal to the in-plane shear modulus (G_{12})

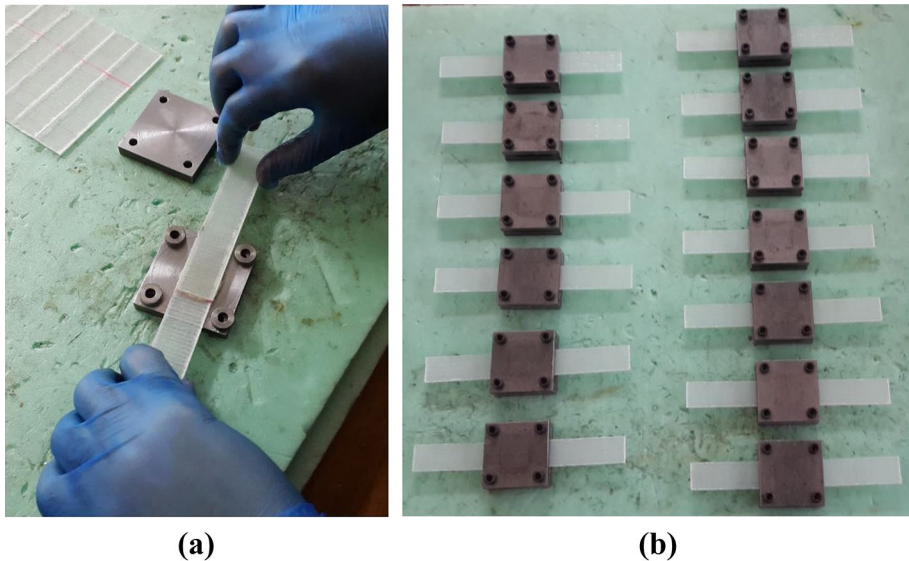
Fig. 3 Preparation of composite single-lap joints: (a) placing the joint between apparatuses (b) holding between apparatuses during adhesive curing

25 × 112.5 mm pieces for 25 mm overlap length and 25 × 120 mm pieces for 40 mm overlap length were cut from the composite plate in 2 mm thickness. Due to the manufacturing method, one of the composite material surfaces was rough and the other surface was relatively less rough and shiny. Adhesive was applied to the rough surfaces to achieve better adhesion strength. In order to remove dirt, dust, and other residues on the bonded surfaces, the surfaces were cleaned with ethanol before the bonding process. Araldite 2015 [49] adhesive was applied to the cleaned bonded surfaces and was spread homogeneously on the surface. The top and bottom apparatuses were used to provide the desired adhesive thickness in single-lap joints. Single-lap joints were placed between the top and bottom apparatuses (Fig. 3a). Four holes of 6 mm diameter in the corner regions of these apparatuses and four 4.2 mm thick washers were used to achieve a uniformly distributed adhesive layer in an adhesive thickness of 0.2 mm. Single-lap joints placed between the top and bottom apparatus were kept for curing at room temperature for 2 days (Fig. 3b).

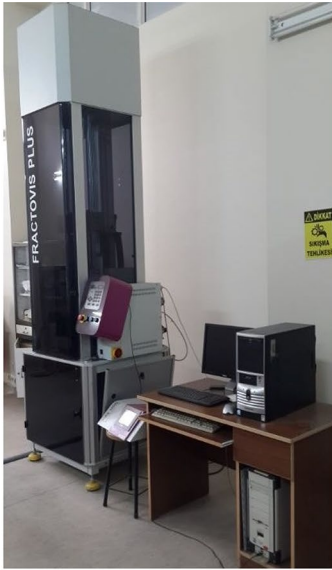
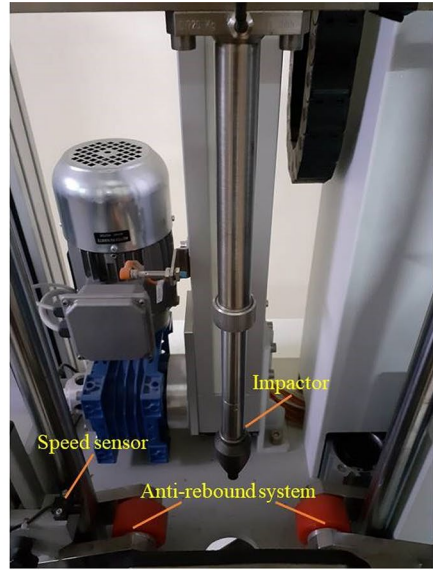
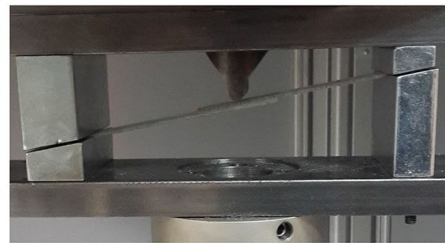
(a) Fractovis Plus impact test device

(b) impact device components

(d) oblique impact test condition

Fig. 4 Fractovis Plus impact test device and specimen holder apparatus (a) Fractovis Plus impact test device (b) impact device components (c) normal impact test condition (d) oblique impact test condition

Low speed impact tests of single-lap joints were carried out via the Fractovis Plus impact test machine. Four different impact angles ($\theta = 0^\circ, 10^\circ, 20^\circ, 30^\circ$) were considered in low speed impact tests. In order to fix the sample in the impact test, one apparatus was manufactured for each impact angle so that the joint can be fixed at the desired angle value, the impact load can be applied to the midpoint of the joint, and the distance between the holders ($L = 160$ mm) can remain the same in all tests. The Fractovis Plus impact test machine and specimen holding apparatus are shown in Fig. 4. The joint dimensions and impact test conditions in this study were determined according to the study performed by Vaidya et al. [50]. The main parts of the impact test machine: the impactor sensor with a capacity of approximately 40 kN that measures the contact force value generated during the test, the speed sensor that measures the speed of the impactor when the impact load is applied to the sample, and the anti-rebound system that prevents repeated impact to the sample. The single-lap joint dimensions used in the impact test are shown in Fig. 5. The effective length ($L = 160$ mm) was kept constant at all impact angles ($\theta = 0^\circ, 10^\circ, 20^\circ, 30^\circ$). The overlap length (b) was determined as 25 and 40 mm in order to examine the effect of the overlap length on the impact behavior. A semi-cylindrical impactor with a radius of 5 mm and a width of 25 mm was used in the impact test. The total mass of the impactor was 5.302 kg. Impact tests were carried out for an impact energy of $E = 3.2 \pm 0.16$ J. After each impact test, contact force–time and contact force–displacement graphs were prepared with the data obtained from the impact machine. The effects of test parameters (impact angle, fiber angle, and overlap length) on contact force–time and contact force–displacement were examined and discussed in detail in the following sections. In addition, damage initiation and propagation mechanisms were evaluated by examining the microscope images of adhesive damage surfaces.

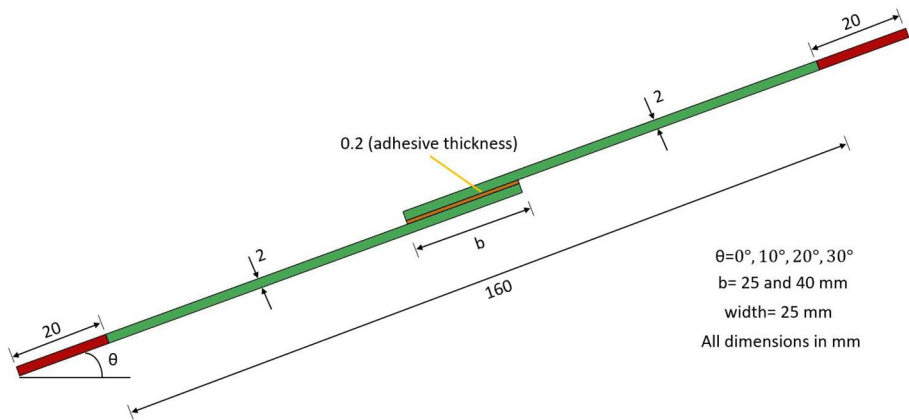
Fig. 5 Dimensions of single-lap joint

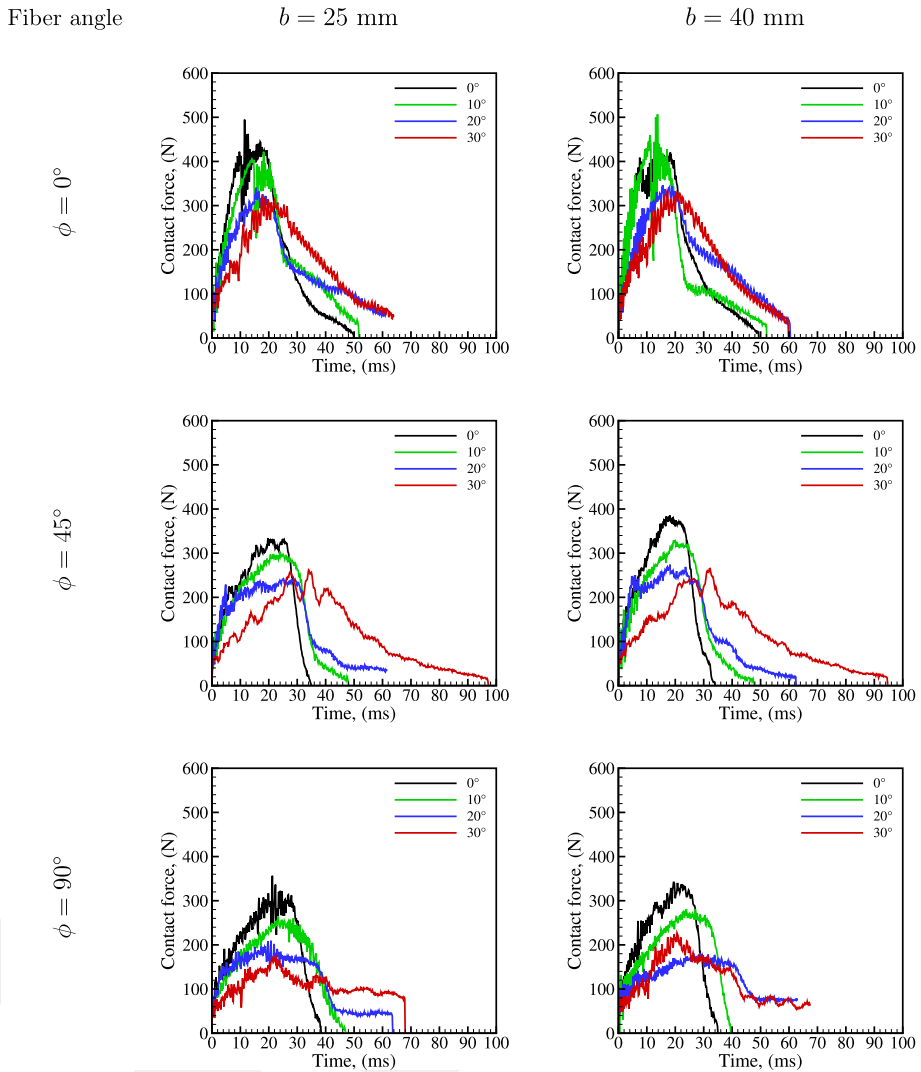
Fig. 6 Contact force–time variations of composite single-lap joints under different impact angles (b : overlap length, ϕ : fiber angle)

Figure 6 shows the effect of the impact angle on the contact force–time variations. The increase in the impact angle decreases the contact force component of the impactor in the normal direction, while increasing the component in the tangential direction. Therefore, the

contact force value decreases, the contact time increases as the lateral area of the impactor contacting the joint increases with the increase of the impact angle. Some amount of the impact energy that the impactor possesses after it encounters the joint is absorbed by the joint, the remaining energy is released as rebound energy. In order to prevent repeated impacts to the joint, the anti-rebound system is activated by the sensors and keeps the impactor up without contacting the sample. However, for large impact angles of 20° and 30° , the increase in the lateral contact surface becomes apparent and the rebound energy of the impactor decreases to very low levels, so the normal component of the contact force cannot reach zero value.

Similarly, in joints with an overlap length of 40 mm, the increase in the impact angle decreased the normal component of the contact force and increased the total contact time. The contact force–time curves were quite similar for the 20° and 30° impact angles. In joints with 45° fiber angle under impact load, rotation about the joint axis occurs due to the unbalanced joint type. Due to the rotation of the joint, the contact surface region between the impactor and the joint increases. The single-lap joints with 45° fiber angle for 30° impact angle had a longer total contact time than the single-lap joints with other fiber angles. In case the contact force–time variations of the joints under the normal impact (0°) are examined, the total contact time is approximately 50 ms in the single-lap joints with 0° fiber angle, while the total contact time is in 30–40 ms for 45° and 90° fiber angles. The single-lap joint with the highest bending strength exhibited the longest total contact time. In case the highest contact force values occurring in the single-lap joints with 25 mm overlap length were compared for 0° – 30° impact angles; the maximum contact force decreased from 494.7 to 317.8 N in the single-lap joints with 0° fiber angle, the maximum contact force value decreased from 333.7 to 262 N in the single-lap joints with 45° fiber angle, and the highest contact force value occurred for 90° fiber angle and decreased from 356.6 to 172.8 N. With the increase in the impact angle, the decrease in the maximum contact force value in the joints was approximately 36, 21, and 52% for 0° , 45° and 90° fiber angles, respectively. For 40 mm overlap length, the rate of decrease in maximum contact force value for 0° , 45° , and 90° fiber angles was 21, 31, and 34%, respectively. As seen, the contact force was directly related to the bending strength of the joint. Namely, the increase in the impact angle and the decrease in the contact force was minimum in the joint with the highest bending strength with 0° fiber angle. The highest reduction in the contact force

level was observed in the joint having 90° fiber angle with the lowest bending strength. In this type of joint, the mechanical properties of the matrix material are decisive in carrying the bending impact load. The shear damage occurring in the matrix region together with the impact load caused the contact force values to be realized at low levels.

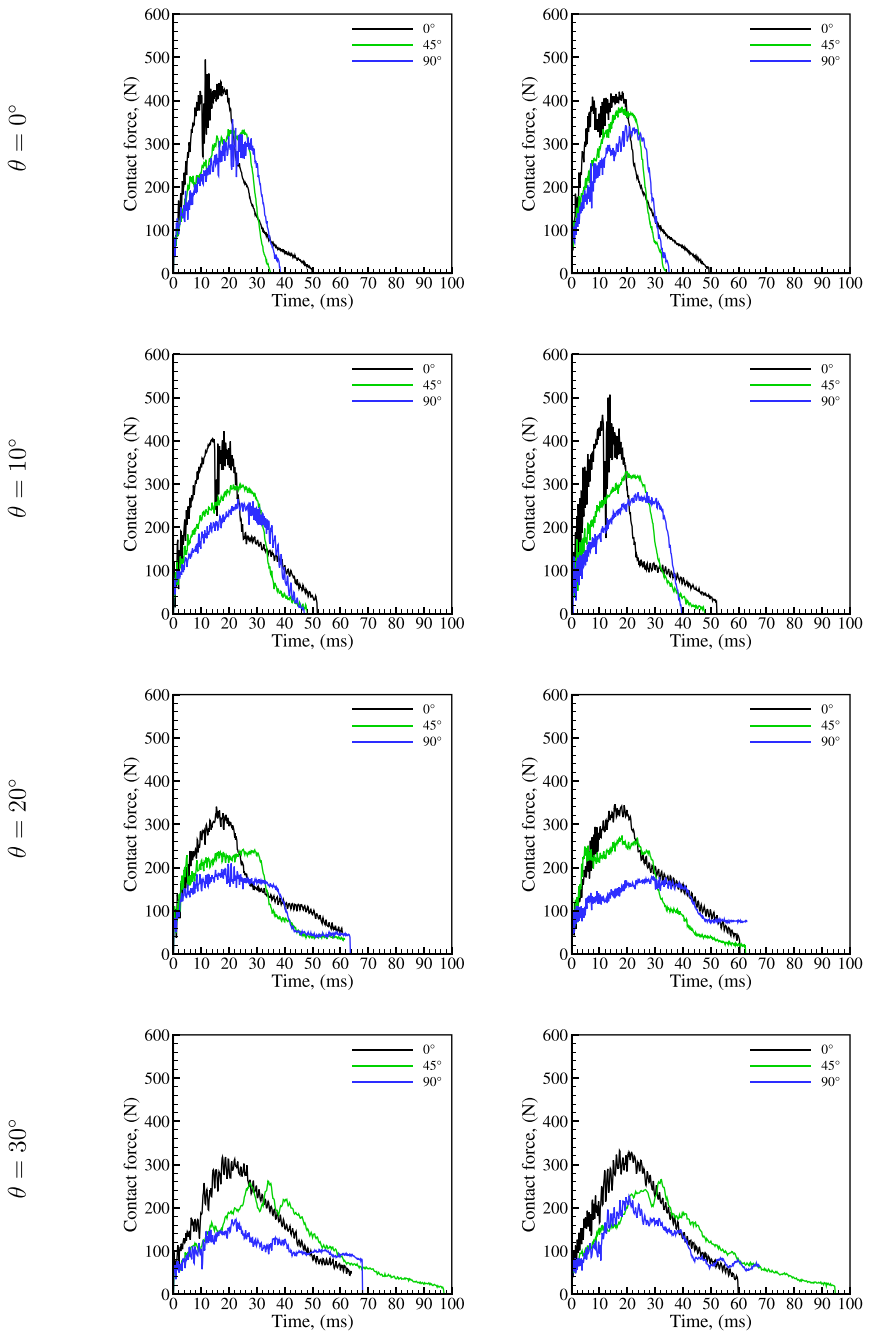
Fig. 7 Contact force–time variations of composite single-lap joints having different fiber angles for different impact angles (b : overlap length, θ : impact angle)

The effect of fiber orientation angles for each impact angle on the contact force–time curve of the joint is shown in Fig. 7. Under normal impact load ($\theta = 0^\circ$), the contact force

reached its highest value in the single-lap joint with 0° fiber angle and decreased with the increase of the impact angle. Similarly, the contact time was longer for 0° fiber angle compared to the joints with other fiber angles. As the impact angle increased, the total contact time for 0° fiber angle increased approximately 10 ms, while the increase in the contact time for 45° and 90° fiber angles reached about 35–65 ms. The fiber angle of the adherends also determines the load carrying capacity of the joints. The joint with 0° fiber angle has the highest load carrying capacity whilst the joint with 90° fiber angle has the lowest load carrying capacity. It was observed from the impact tests that the joint with a low load carrying capacity was more sensitive to the increase in the impact angle.

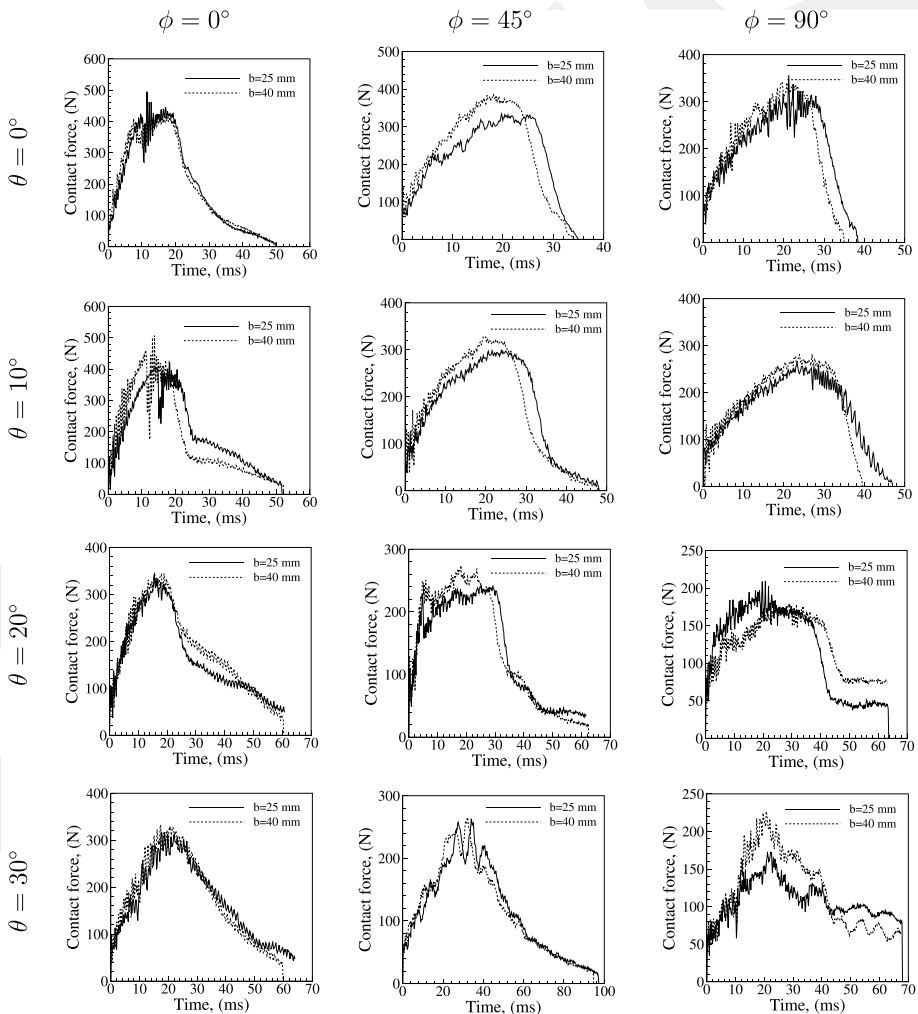
Fig. 8 Contact force–time variations of composite single-lap joints with different overlap lengths (b : overlap length, ϕ : fiber angle, θ : impact angle)

The effect of overlap length on contact force–time variations is shown in Fig. 8. As the bonding area increases with the increase in overlap length, the load carrying capacity of the joint also increases. For $E = 3.2$ J impact energy, the contact force–time variations were quite similar in the single-lap joints with overlap lengths of 25 and 40 mm. The similarity in these changes decreased with the increase in the amount of damage in the composite adherends. In the joint with the highest load carrying capacity (0° fiber angle), while the contact force–time variations in both overlap lengths were quite close to each other, the proximity between these variations decreased slightly in the joint with the lowest load carrying capacity (90° fiber angle). The maximum contact force slightly increased with increasing overlap length. Similar results were obtained by the researchers under both in-plane and out-of-plane impact loads [21, 26]. Since the increase in overlap length increases the strength and stiffness of the adhesive joints, the maximum contact force value and failure load of the joint is expected to increase under in-plane and out-of-plane impact loads. Matrix shear damage was observed apparently in the composite adherends with 90° fiber angle. A longer overlap length can improve bending stiffness. Although there was a negligible increase in contact force levels, not all of the applied impact energy could be dissipated by the joint with 90° fiber angle. Adhesively bonded joints are expected to maintain their structural integrity under impact load. The joints with 90° fiber angle were damaged at free edges by matrix shear damage for all impact angles under 3.2 J impact energy. For this reason, joints with 90° fiber angle were insufficient to meet the applied impact energy due to loss of structural integrity.

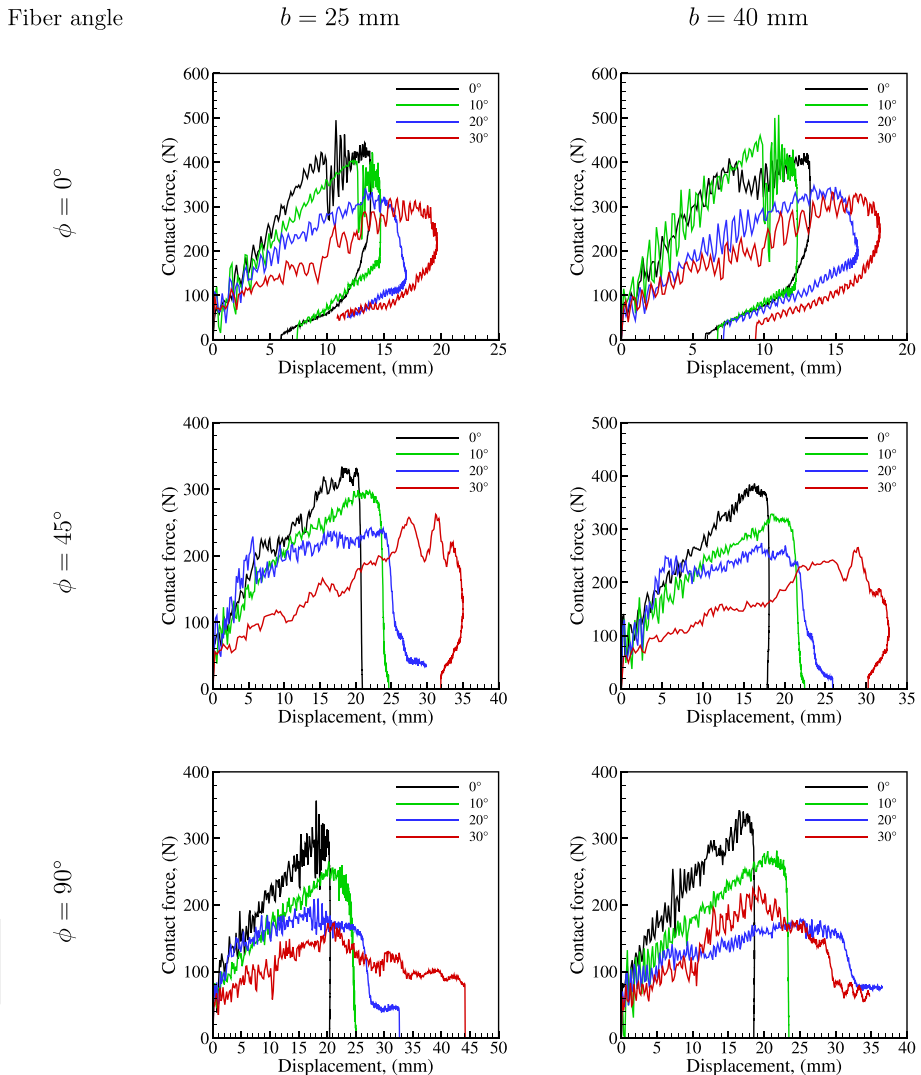
Fig. 9 Contact force–displacement variations of composite single-lap joints for different impact angles (b : overlap length, ϕ : fiber angle)

The contact force–displacement variation of the joints under impact load is presented in Fig. 9. The vertical displacement value supplies information about the bending stiffness of the joints as well as the elastic energy storage of the joints under impact load. In addition, fluctuations in the contact force give information about the amount of damage that occurs in the joints. For joints with 0° fiber angle, the vertical displacement value increased up to the maximum contact force level, and after this point, the displacement value tended to decrease because it released the elastic energy stored. The elastic energy released by the joints in the rebound phase decreased as the impact angle increased. Adhesive damage was observed to be intense in the joints with 0° fiber angle. Therefore, significant fluctuations occurred in the contact force. The elastic energy storage capability of the joints was low, as significant damage occurs in the composite adherends in the joints with 45° and 90° fiber angles. Since the composite adherends and adhesive underwent damage in the joints with 45° fiber angle, the fluctuation amplitude in the contact force was higher. Matrix shear damage was more dominant in the composite adherends for the joints with 90° fiber angle. For this reason, the fluctuations in the contact force histories occurred intensively for joints with 90° fiber angle. The increase in the impact angle caused an increase in the vertical displacement value in the joints for all joint configurations. For a range of impact angle from 0° to 30° , the increase in the maximum vertical displacement value for joints with 25 mm overlap length was approximately 83, 53, and 116% for joints with 0° , 45° , and 90° fiber angle, respectively. In addition, for 40 mm overlap length, there was an increase of 62, 70, and 88% for joints with 0° , 45° , and 90° fiber angle, respectively.

As seen, the impact and fiber angle have a significant effect on contact force level, total contact time, and peak displacement. In the joint with 0° fiber angle, the orientation of fibers carries the applied impact load effectively. In the joints with 45° and 90° fiber angles, the load carrying capacity of fibers gradually decreases and the applied impact load is carried by the matrix material. As a result of the shear stress increasing through the thickness of the composite adherend, the matrix material was damaged, and delamination damage also occurred along the fiber–matrix interfaces. The damage in the composite adherends caused the maximum contact force to decrease and the total contact time to increase. The impact load was sustained by both fibers and adhesive layer in the 0° fiber angle joint, by the fiber, matrix, and adhesive layer in the joint with 45° fiber angle, and by both matrix

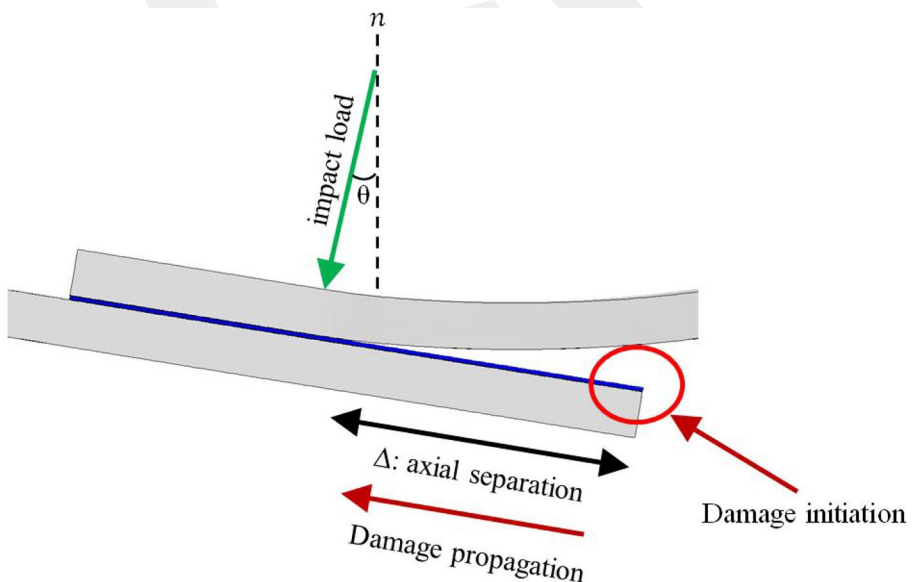
Fig. 10 Schematic representation of adhesive damage propagation in the joint under impact load

The adhesive damage initiation and propagation under impact load are shown schematically in Fig. 10. Adhesive damage initiated from the right free edge and propagated through the overlap region. The axial separation length (Δ) was determined by considering where the adhesive damage initiated and ended. Under normal impact load, the initiation and propagation of adhesive damage occurred with the effect of peak peel stress in the free edges of damaged overlap region. However, under oblique impact, the impact load has two force components. The force normal to the joint caused adhesive damage due to its peeling effect, while the tangential force component parallel to the joint caused adhesive damage with a shear effect. The force components of the impact load which cause shear and peeling effect in adhesive layer depend on the impact angle. As the impact angle increases, the tangential force component increases while the normal force component decreases. The axial separation lengths of composite single-lap joints for different impact angles are presented in Fig. 11. The maximum axial separation length appeared in the joints having the highest bending strength with 0° fiber angle. Both adhesive and adherend undergo damage. Since the weakest part is adhesive layer in the joint with the highest bending strength, the adhesive damage is immense. The minimum axial separation occurred in the joints having the lowest bending strength with 90° fiber angle. In the joints with 90° fiber angle, the impact energy was absorbed only both matrix and adhesive. Matrix shear damage, rather than adhesive damage, was observed in these joints due to higher shear stresses at the free edges of the overlap region. The axial separation length (Δ) also decreased with increasing impact angle. Therefore, this indicates that the resistance of adhesive against shear stress was higher than those against the peeling stress.

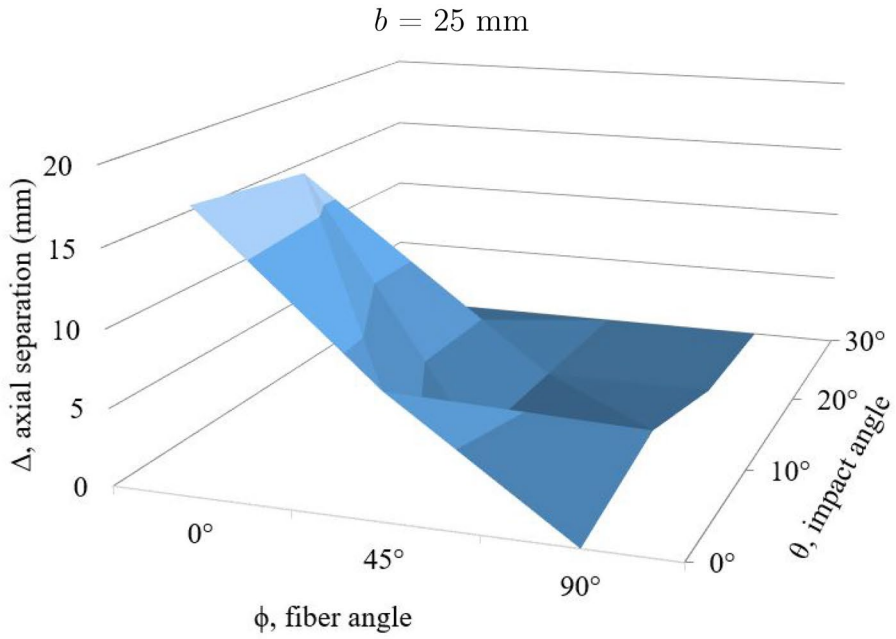
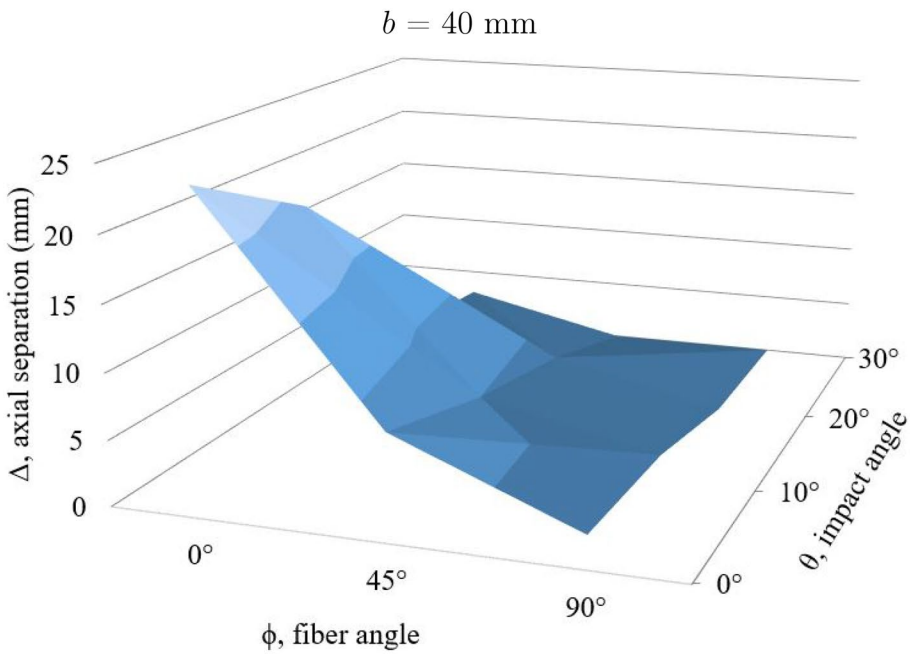
Fig. 11 Effects of fiber angle and impact angle on axial separation of composite single-lap joints (b : overlap length)

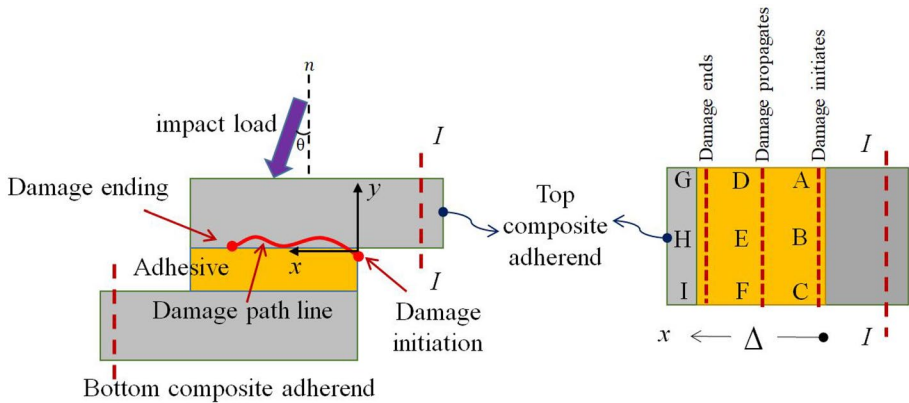
Fig. 12 Schematic representation of microscope images of the fracture surfaces of joints (Figs. 13, 14, and 15)

The microscope images of fracture of adherends surfaces are shown in Fig. 12. Microscope images were taken along the top composite-adhesive interface. The microscope images taken from the damaged surface of the joint with 0° fiber angle and 25 mm overlap length under normal impact are shown in Fig. 13. The amount of adhesive residues on the surface was denser in the selected regions (A, B, C) in the damage initiation zone. Delamination damage occurred in the top composite material around the adhesive, resulting in the emergence of fibers. The microscope images indicated that the peeling effect occurring in the initiation region of damage under bending impact load caused the fibers to rupture. In regions where the damage progressed (D, E, F), mostly delamination and fiber-tear damage occurred. In the damage-ending zone, a large amount of adhesive residues was seen on the fracture surfaces. This implies that the damage in the joint initiated in the adhesive, then progressed at the upper composite-adhesive interface and penetrated in to the composite, thus causing fiber breakages and progressing into the adhesive layer towards the end zone. In the joints, adhesive and epoxy are two materials, whose mechanical properties are relatively weak compared to fibers. The damage initiated from the weak region in the joint subjected to peeling effects and even caused fiber-tear due to the impact energy.

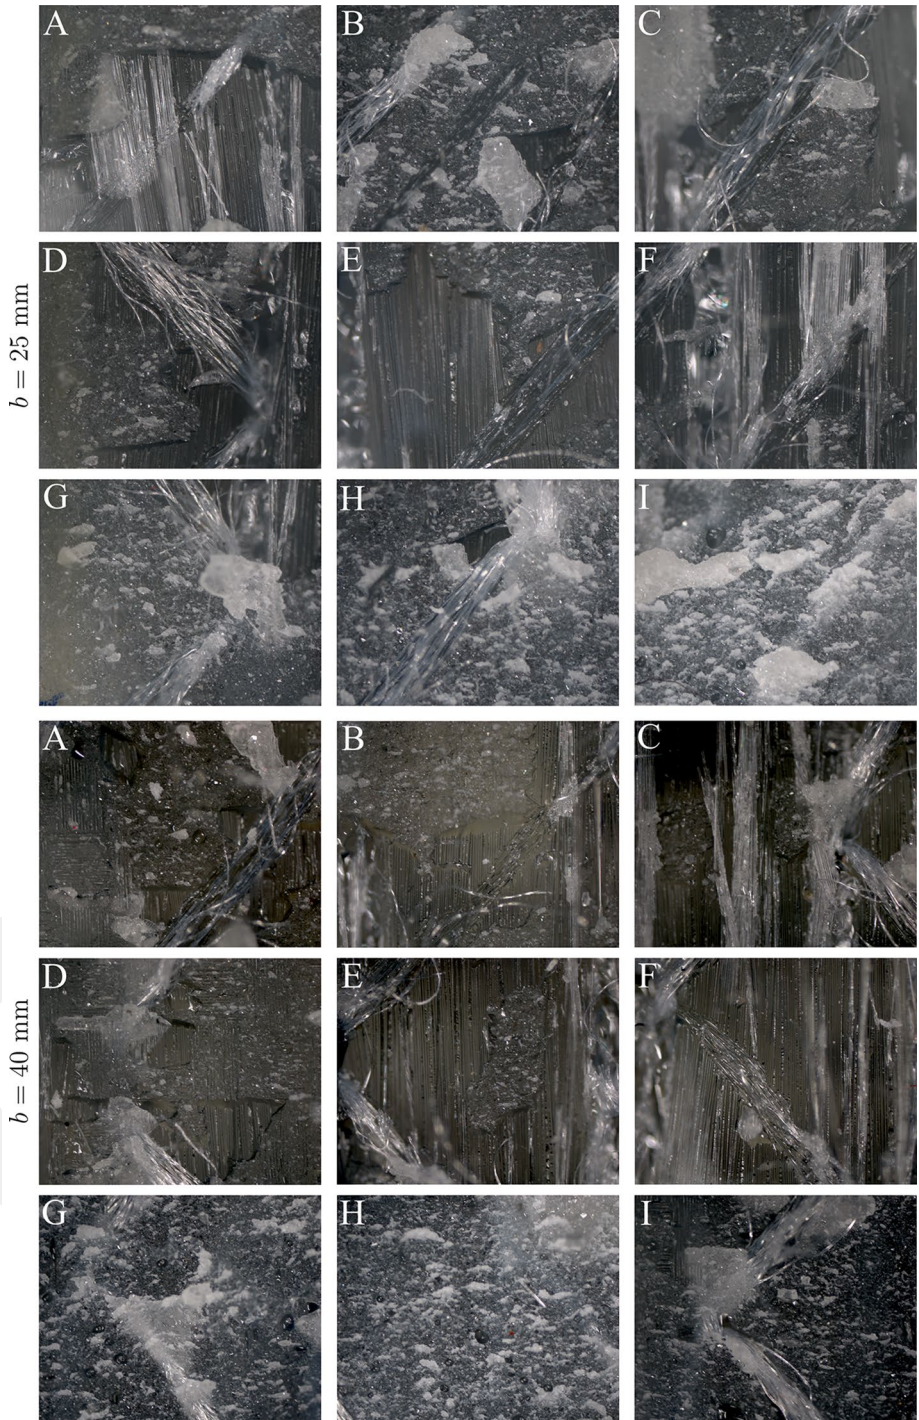
Fig. 13 Microscope images of the damaged top composite-adhesive interface of the joint with 0° fiber angle and 0° impact angle (b : overlap length)

The microscope photographs of the damage surfaces of the joint with 40 mm overlap length are shown in Fig. 13. In the joint, since the bending stiffness increased with increasing overlap length, delamination and fiber-tear damage were also observed. The increase in bending stiffness caused the damage to initiate in vicinity of the interface between the

composite and adhesive instead of through the adhesive layer. In the damage propagation region, the fibers due to delamination emerged. Fiber-tear damage also occurred in these regions. Adhesive residues appeared in the damage-ending zone. The damage towards the damage-ending zone was progressed mostly inside the adhesive. Namely, the adhesive residues on the damaged surface of the top composite adherend significantly reduced.

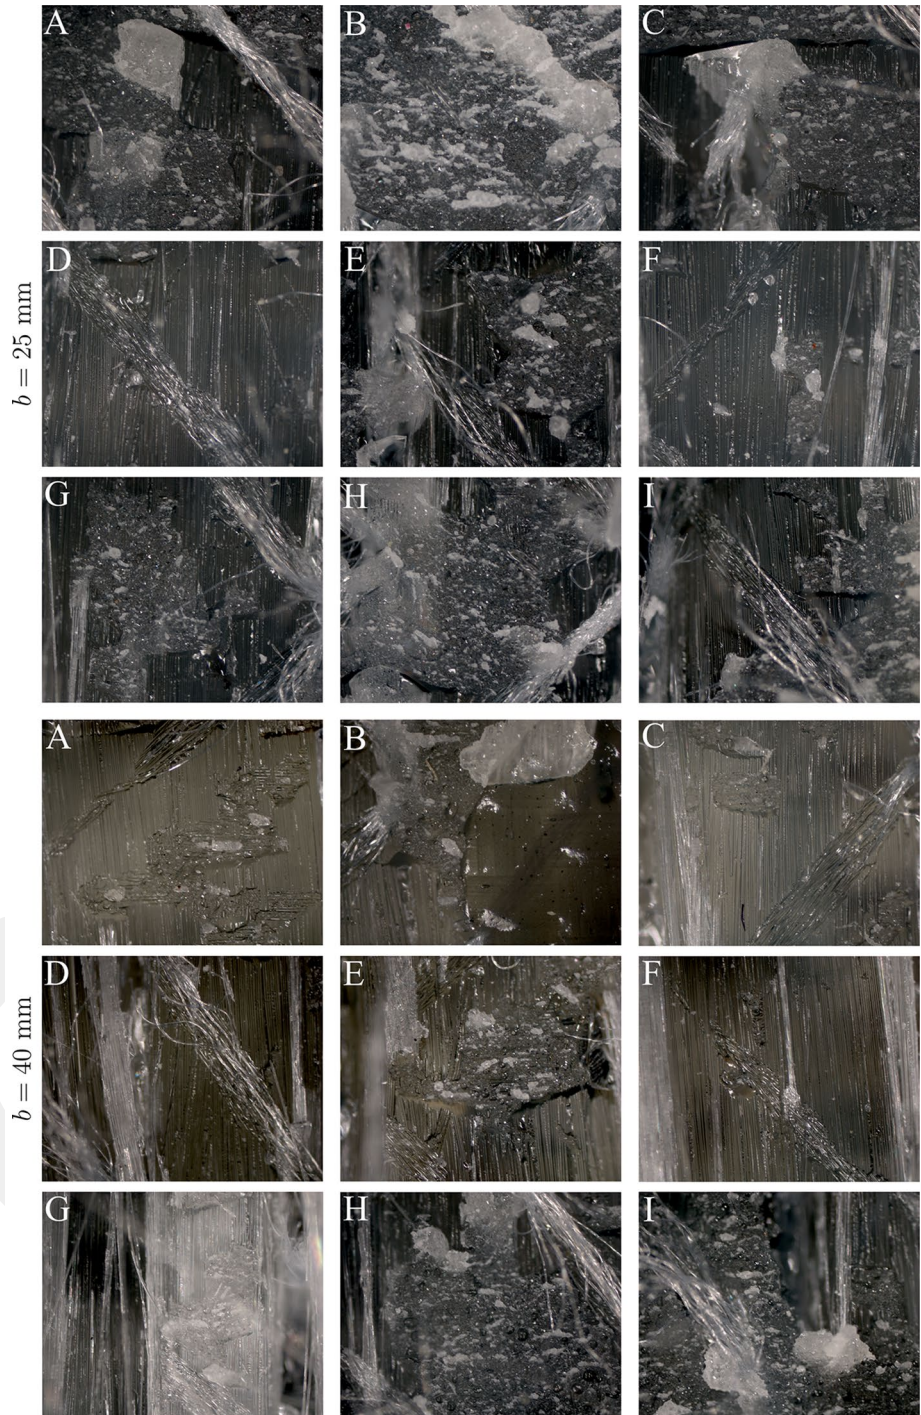
Fig. 14 Microscope images of the damaged top composite-adhesive interface of the joint with 0° fiber angle and 10° impact angle (b : overlap length)

The effect of impact angle on the damage initiation and propagation is visualized with the photographs of damaged surfaces in Fig. 14. The increase in the impact angle caused the initiation of damage to be largely developed in the adhesive layer. The damage in the adhesive material due to shear stress also increased with increasing impact angle. Fiber-tear damage decreased with increasing impact angle. The effect of peeling stresses is apparent on fiber-tear damage. The damage initiated in the adhesive layer, and spread along the adhesive region close to the top composite-adhesive interface.

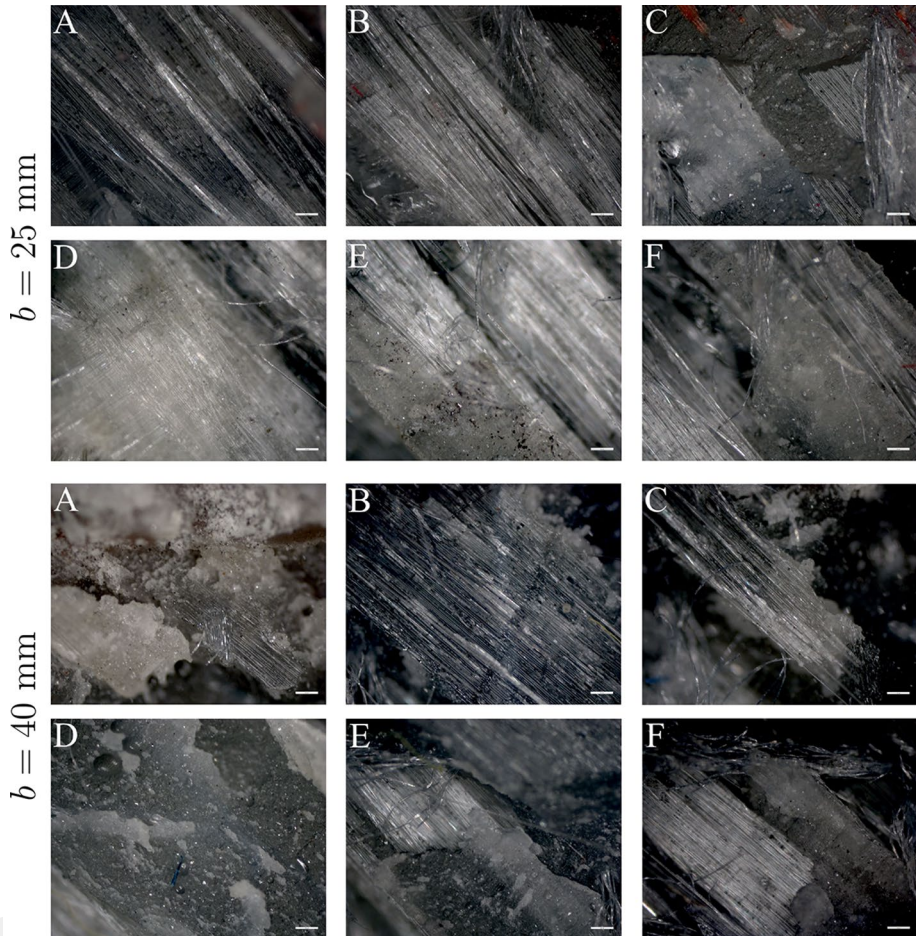
Fig. 15 Microscope images of the damaged top composite-adhesive interface of the joint with 45° fiber angle and 0° impact angle (b : overlap length)

The joint with 45° fiber angle cannot carry the load evenly in the adherend plane, so the joint is forced to rotate about its longitudinal axis. The effect of this unbalanced in-plane shear force distribution on the damage is shown in Fig. 15. The joint was usually damaged in the 45° fiber direction. The moment due to the unbalanced in-plane shear force distribution also contributed to the state of shear stress in the overlap region. In case the microscope images of damaged surfaces were examined, the damage occurred within the adhesive layer and propagated along the top composite and adhesive interface. The broken fibers are clearly seen in the micro-photographs of damage surfaces. The matrix (epoxy) also underwent significant damage as a result of higher shear stress distribution in the overlap region. The increased shear stresses in the joint with 45° fiber angle (unbalanced joint) were evident in the adhesive and epoxy matrix. However, the effect of the increase in shear stress levels is of a negligible effect on fiber-tear damage. The damage mechanism of adhesively bonded joints under transverse low-speed impact has been investigated in some studies in the open literature [14, 26, 28, 33, 50]. He and Pan [28] reported that the predominant damage type was matrix shear damage and adhesive damage initiated from the free edge and propagated through the overlap region. Liu and Yan [33] stated that adhesive damage, matrix shear damage, and delamination occurred together in joints due to the transverse impact load. In general, it was attempted to determine the relationship between peel and shear stress distributions in the overlap region and adhesive damage
